# APPENDIX B - OSIM INSPECTION REPORT, 2019

# Ontario Structure Inspection Manual - Summary Report

AEID: 20195369000

Structure Name **NIAGARA STREET BRIDGE**

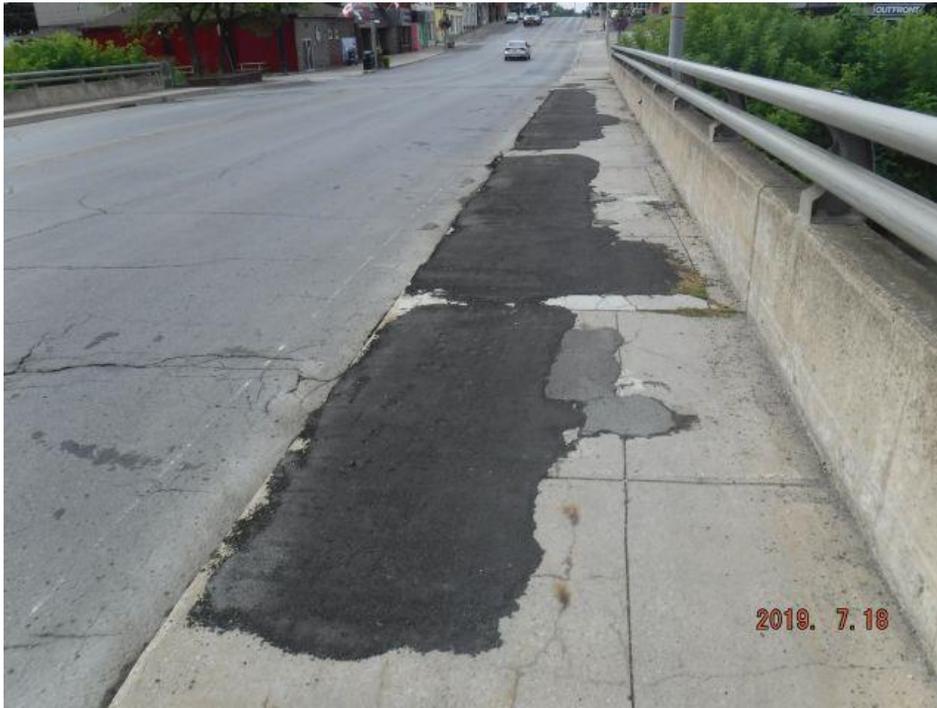
Comments: Areas of delamination with the first layer of concrete scaling off. Asphalt has been used to patch up some areas of the sidewalk. Several longitudinal cracks run along east and west sidewalks. Recommend casting new sidewalk sections in areas of severe deterioration.

Asphalt patch repairs on west sidewalk. With some localized cracking

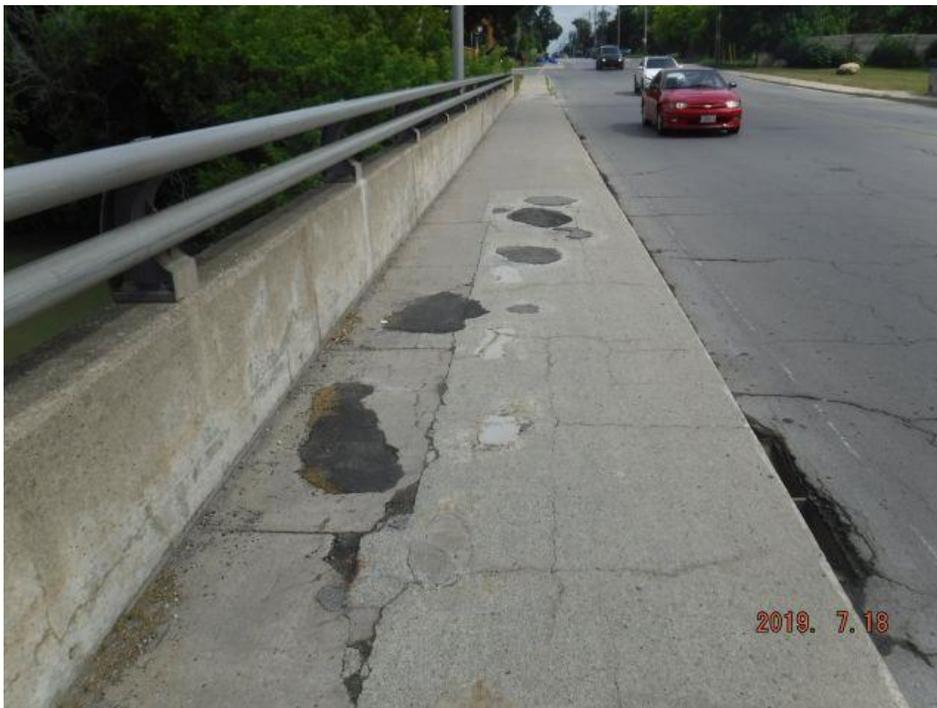
Delaminated concrete and asphalt patch repairs on sidewalk near northwest corner of bridge

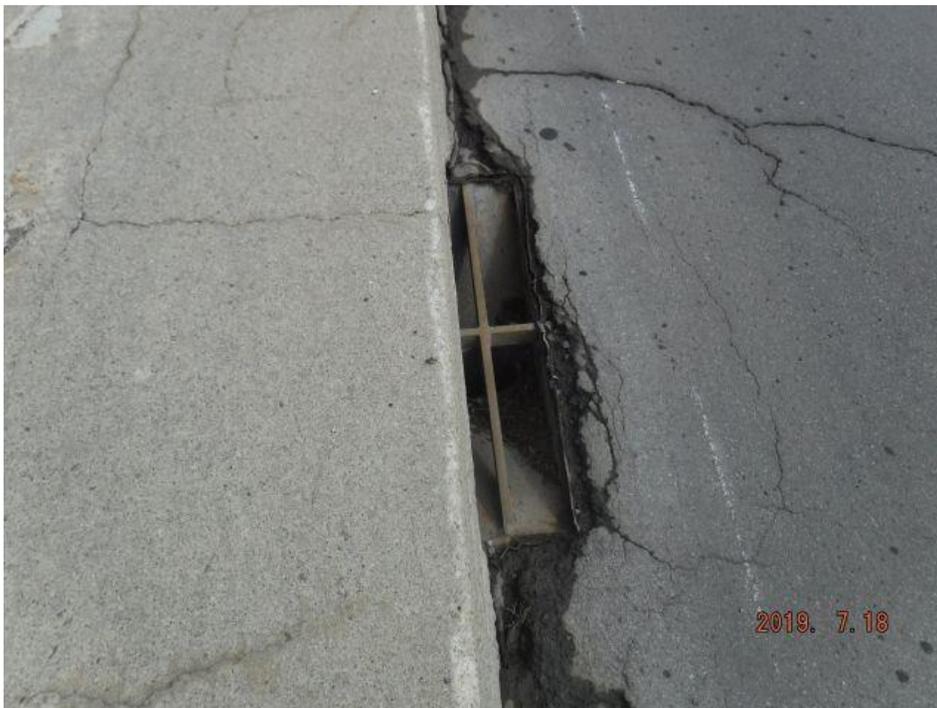
Comments: Steel deck drains are have light to medium corrosion throughout

Deck drain, typical

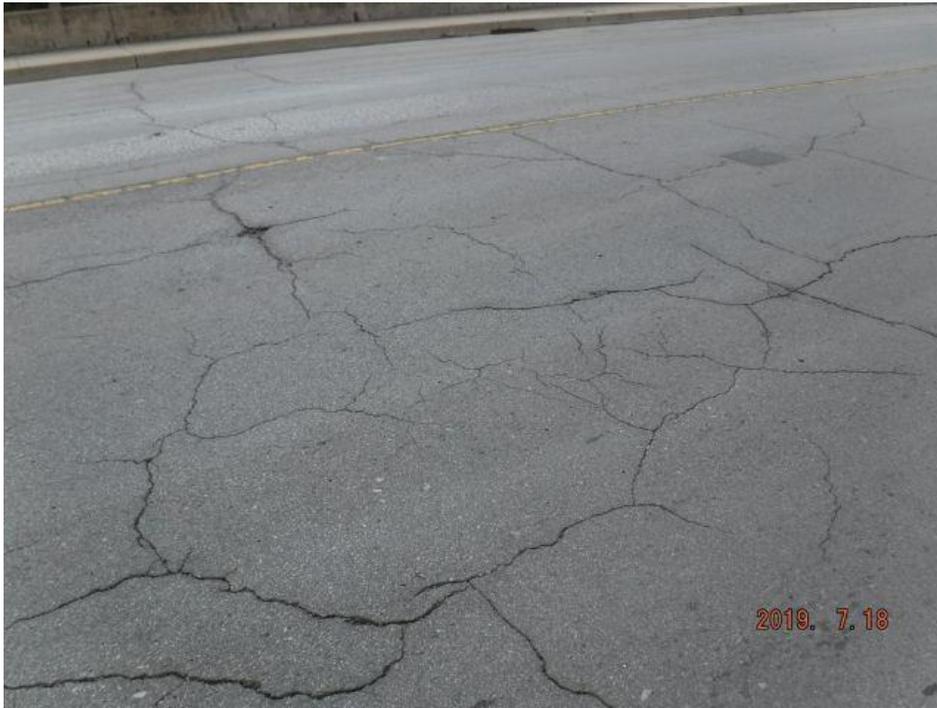
Comments: Wearing surface has localized areas of alligator/map cracking.

Map cracking on wearing surface with potholes

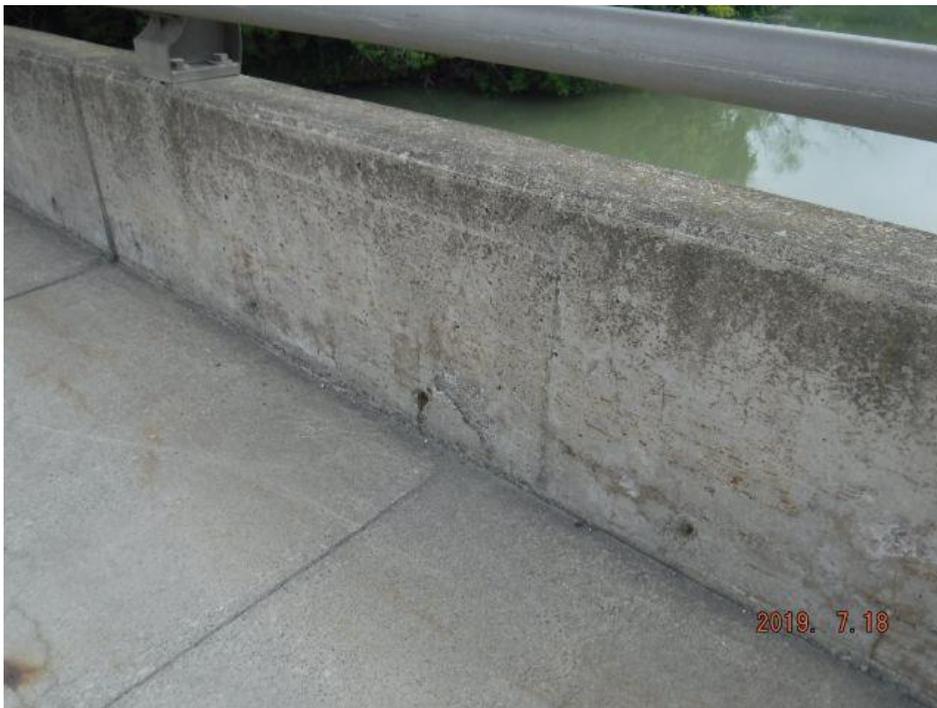
Bridge parapet wall, light scaling typical

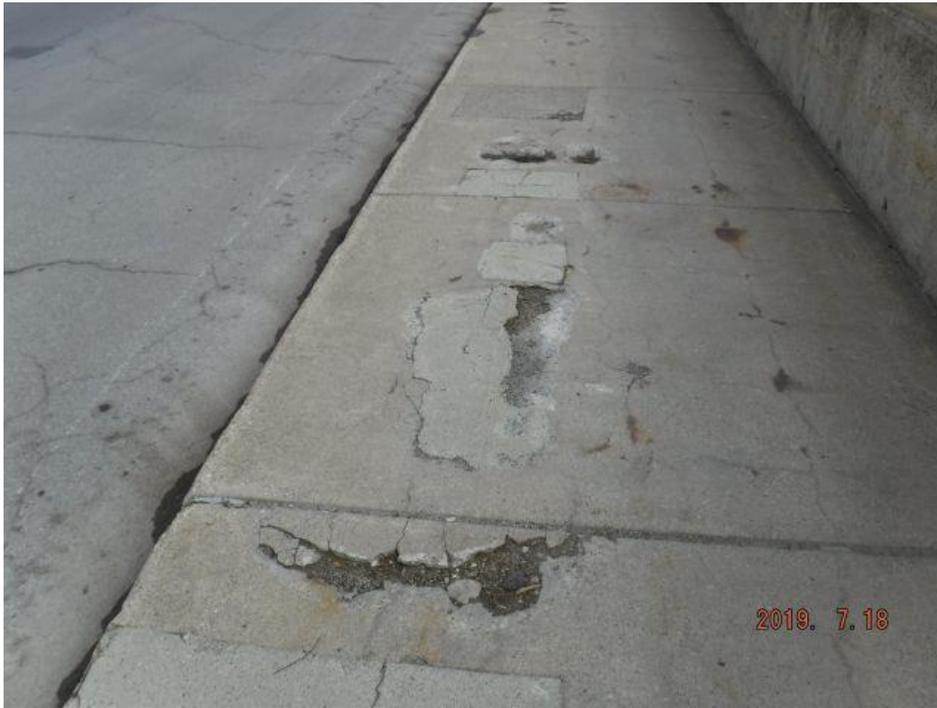
Concrete delamination on sidewalk on east side

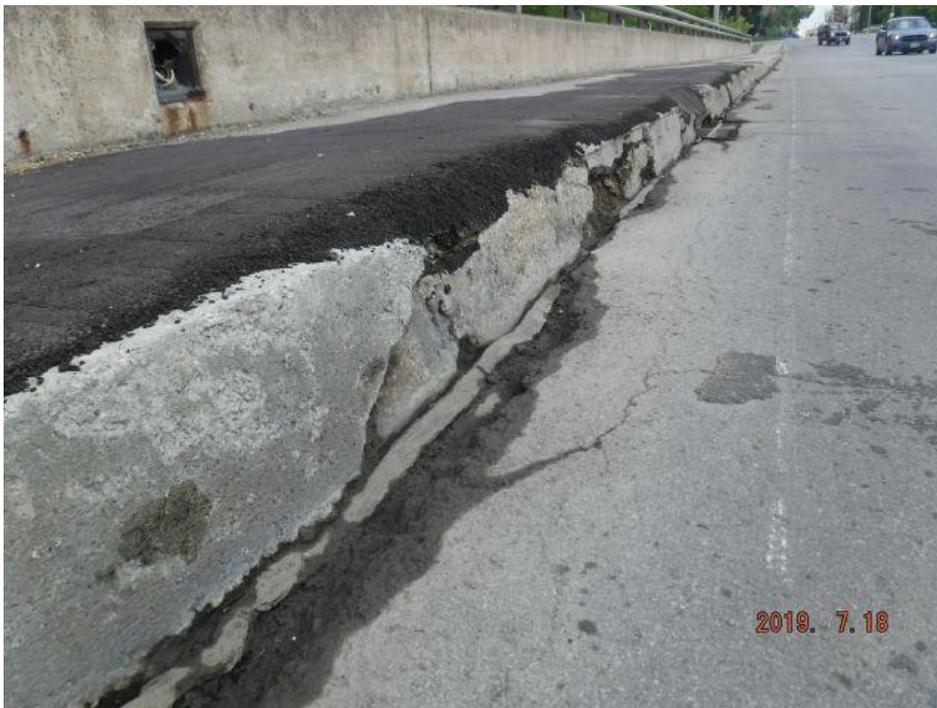
Comments: Areas of concrete spalling along curbs which have been repaired. Cracking at localized areas. Recommend repairing areas where severe concrete deterioration occurs

Severe deterioration on west curb which has been patch repaired with asphalt

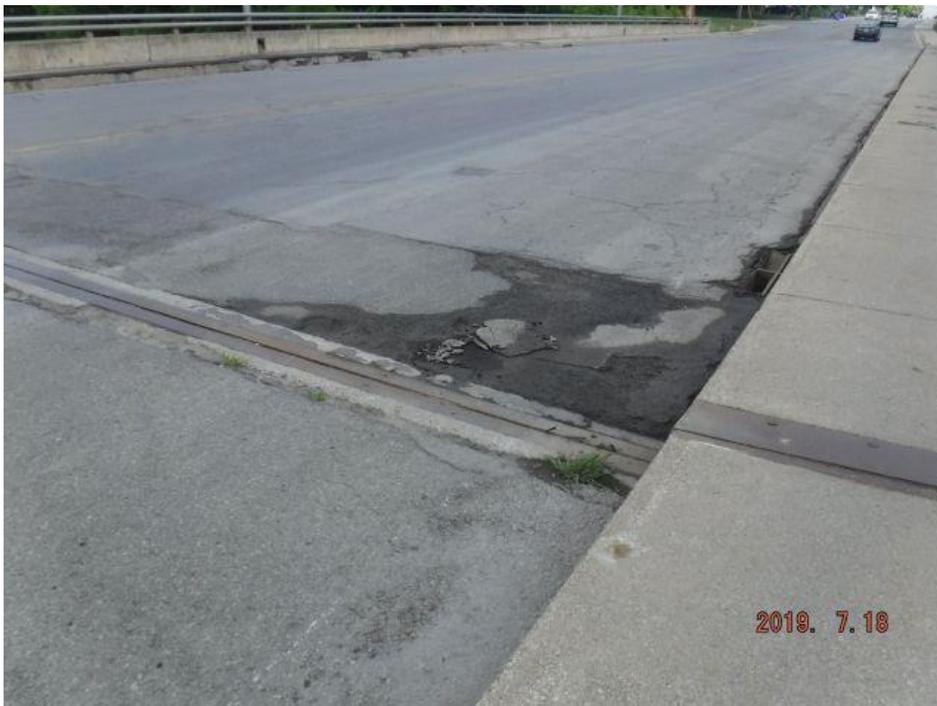
Minor settlement and wet spot on bridge deck at southeast corner

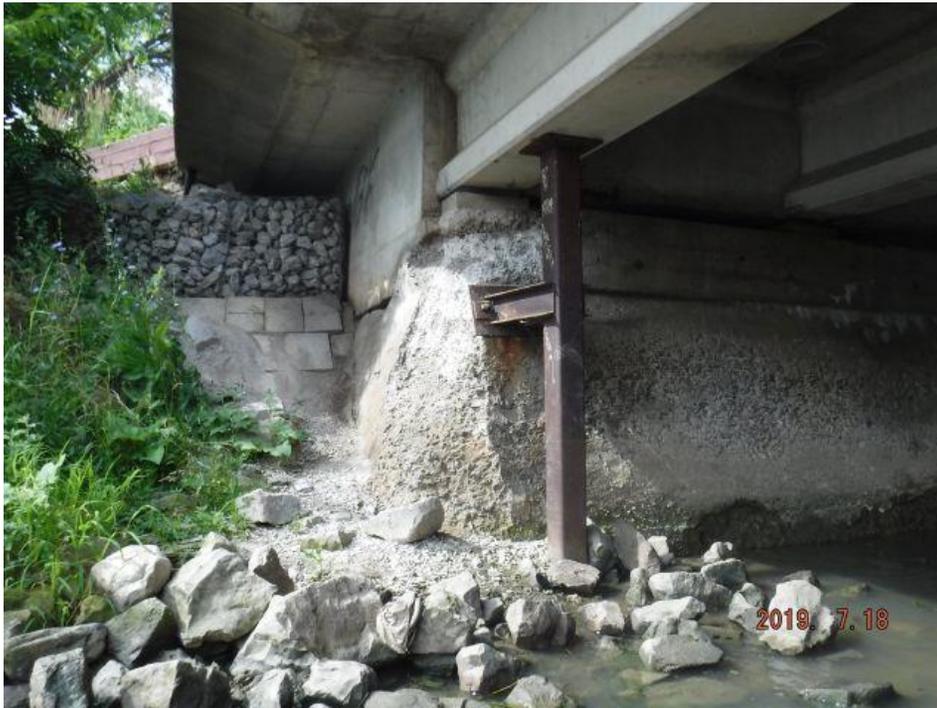
Comments: South abutment at east corner has a large spall under bearing pedestal. Light to medium scaling along waterline of abutment walls.

South abutment at east corner. Severe spalling and concrete disintegration with steel repair

Repair/Rehab Comments:		Recommended Work:	
Maintenance Needs:	Repair to Bridge Concrete	Maintenance Priority:	None

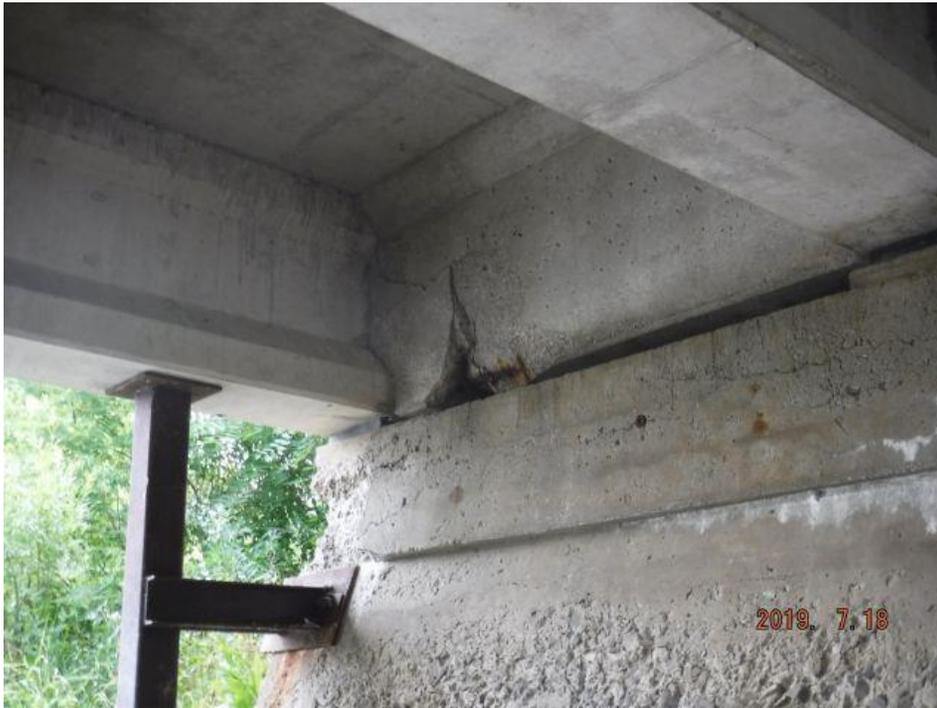
Comments: Medium cracking of exterior girder near Pier 2 on east side. At South abutment medium to wide cracking on girder near ends.

Large spall and wide crack at southeast corner of abutment diaphragm

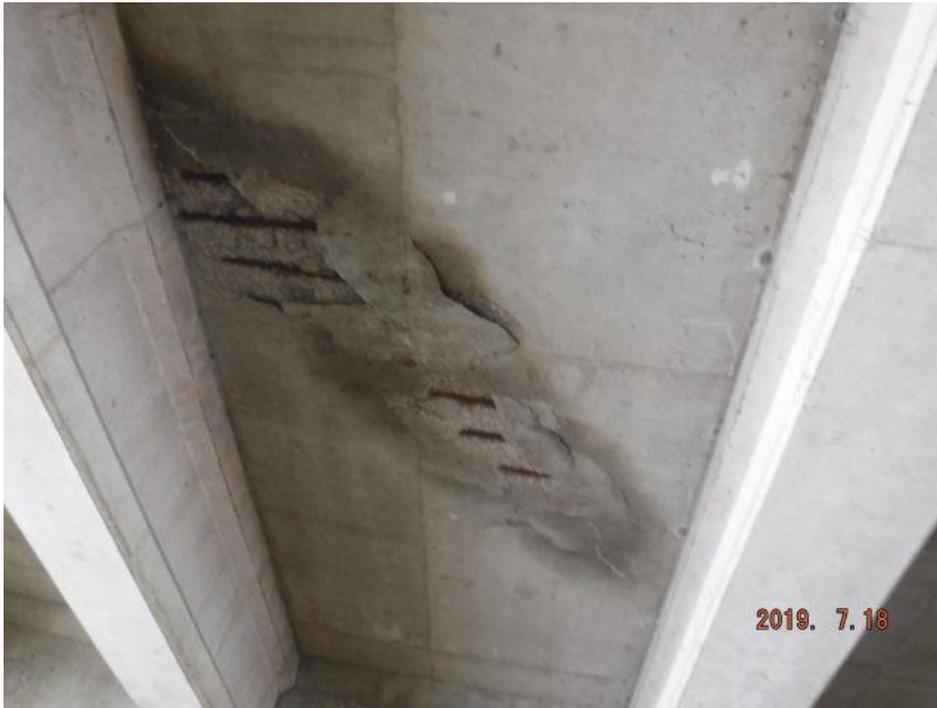
Comments: Several areas of severe spalling with exposed reinforcing steel. Areas of active wet patches with signs of delamination. These occur near the middle spans in between interior girders

Large spall at deck soffit between interior girders with exposed reinforcing steel

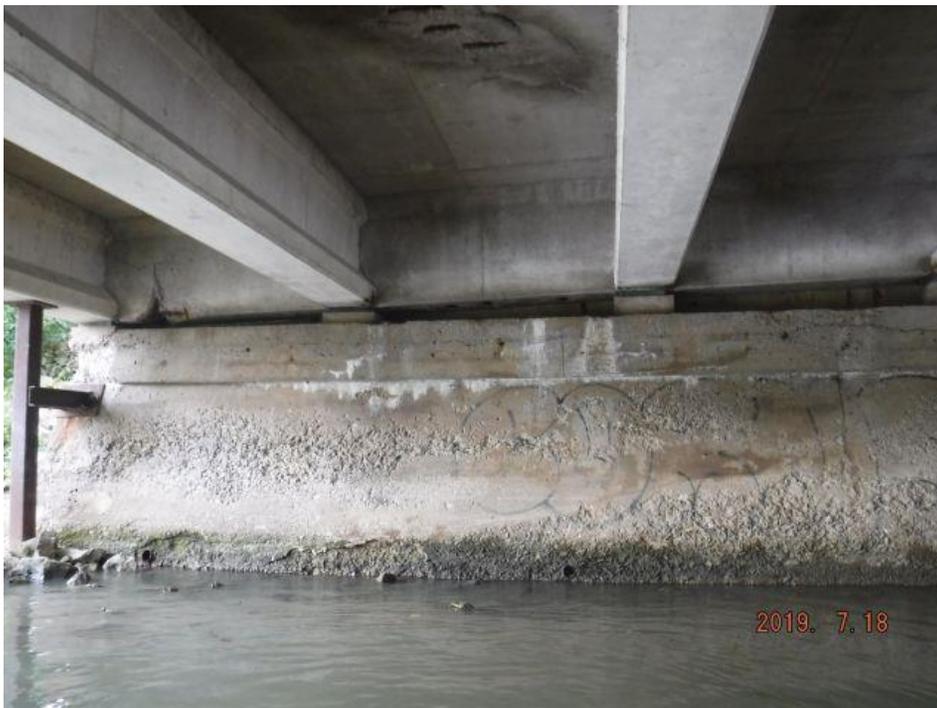
South abutment wall, concrete scaling

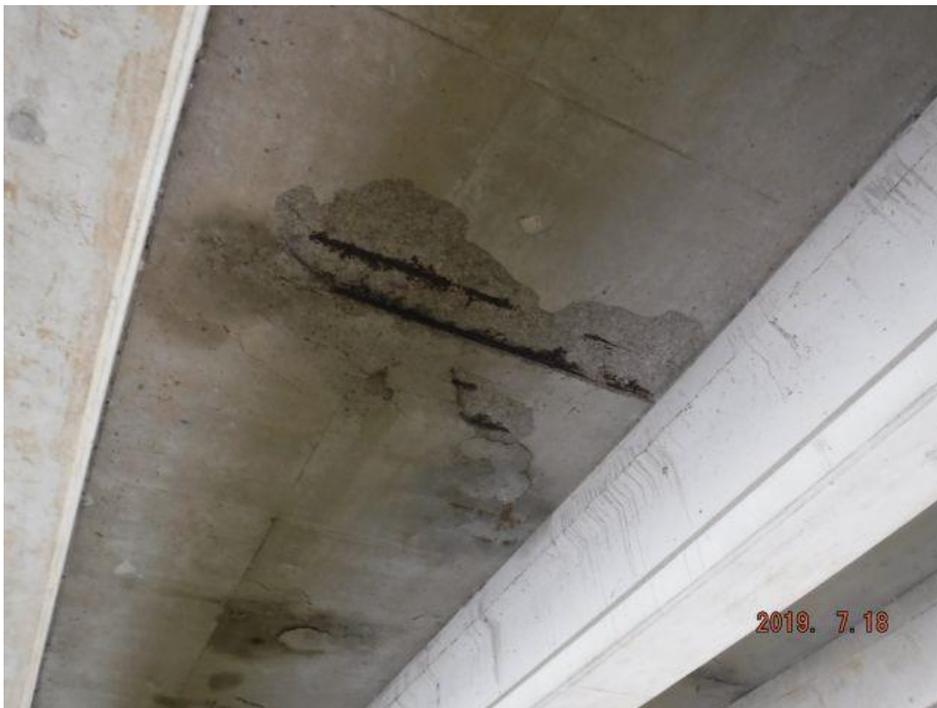
Concrete spall and delaminatio with exposed reinforcing steel at bridge soffit

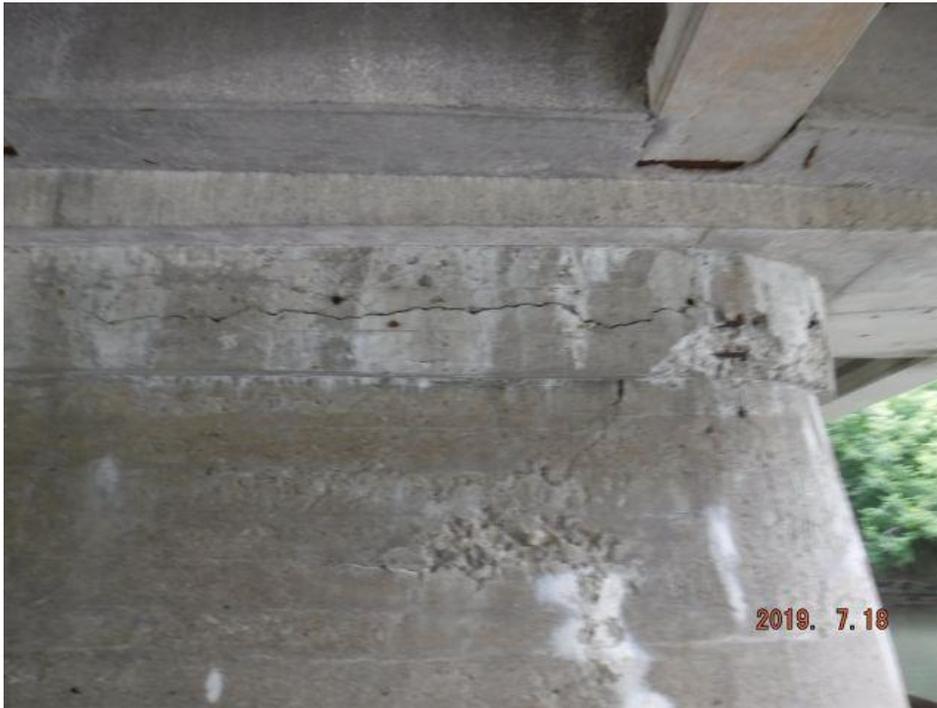
Comments: Piers 2 and 3 have medium to wide cracking propagating from the east side near the top.

Comments: Pier shafts are in good condition. Localized areas of concrete scaling and delamination. Some cracking noted near the top portion of Piers 2 and 3

Wide cracking near top of pier wall with concrete spalling

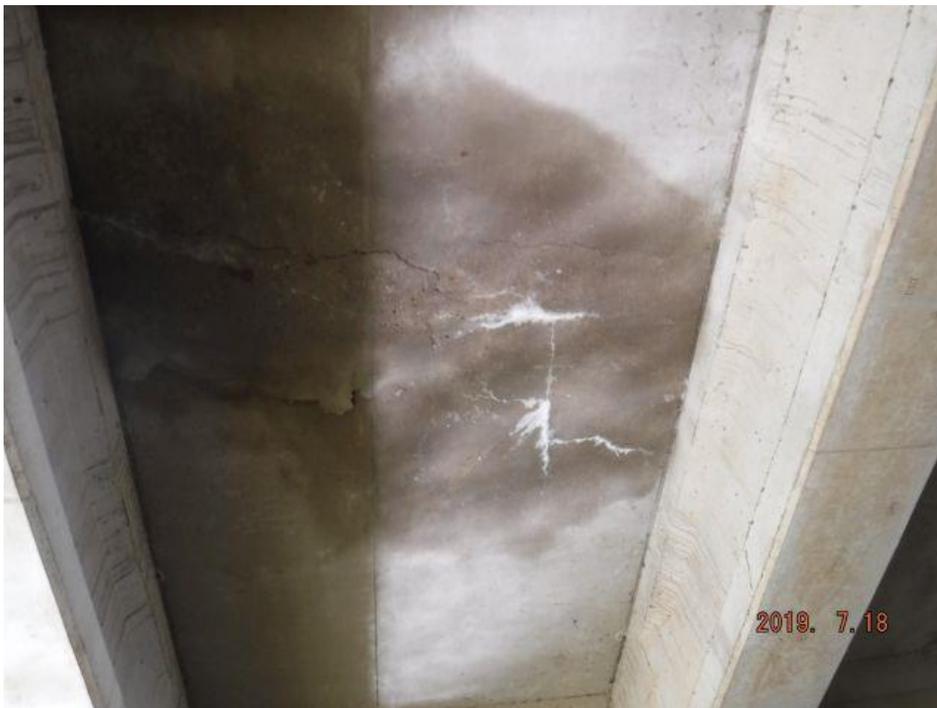
Active wet spot at bridge soffit with signs of delamination

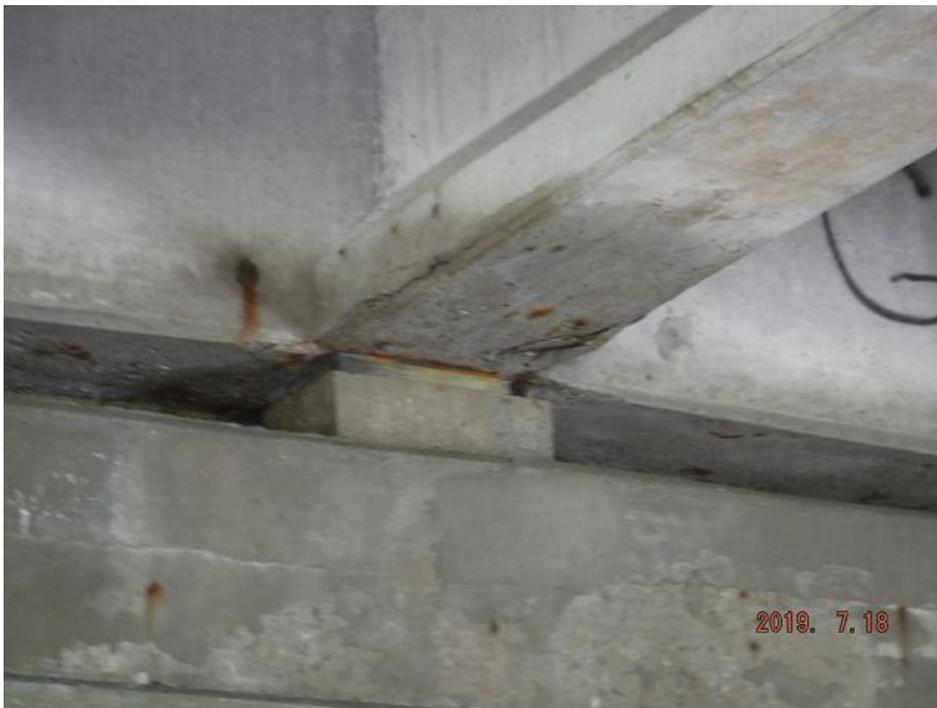
Bearing pedestal with cracking of girder at north abutment interior
