## **ROAD SAFETY AUDIT (CIMA+)**

## Road Safety Audit – Preliminary Design Stage

Regional Road 20 - Lundy's Lane

Montrose Road to Highland Avenue

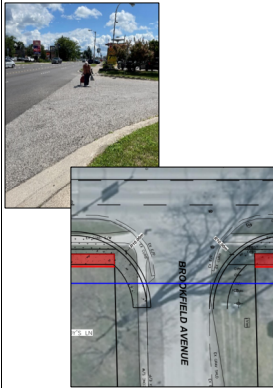
| Issue # | Sheet # | Location | Safety Issue | Photo | Suggested Action/Proposed Concept | Project Owner Response | Resolution |
|---|---|---|---|---|---|---|---|
| 5 | All | Various - Brookfield Avenue (north and south leg), Moulnd Avenue, Depew Avenue, Corwin Avenue, Carlton Avenue, Prince Edward Avenue, Byng Avenue, Franklin Avenue and Glenholme Avenue. | At a number of local unsignalized intersections along the corridor, the curb radius has been increased to 10.0 metres. While this may reflect current Regional standards, as a result of this, vehicle turning speeds to/from Lundy's Lane at these locations will increase and pedestrian's exposure to traffic will significantly increase. These locations lead into residential areas and there is no evidence of the need for a larger footprint to accommodate commercial vehicles (i.e. no evidence of trucks mounting the existing curbs). Stop bars and crosswalks are generally not shown at the local intersections. The relocation of sidewalks, while benefitting from a placement set back from the roadway, will mean that the stop bar needs to be set back a significant distance from the roadway. Finally, increasing the radius at these local intersections will decrease the distance to nearby commercial accesses, increasing the potential for conflicts between vehicles proceeding east and west on Lundy's Lane and vehicles turning into and out of accesses. | | Revisit the need for a 10.0 metre curb radius at all local intersections in the context of the swept path of the design vehicle and consider keeping the existing curb radius in place. Review the placement of the crosswalk and the stop bar in the context of sightlines for turning movements (left and right turns from the local intersection onto Lundy's Lane) and corner clearance to adjacent commercial accesses.<br><br>This comment applies to the following locations: Brookfield Avenue (north and south leg), Moulnd Avenue, Depew Avenue, Corwin Avenue, Carlton Avenue, Prince Edward Avenue, Byng Avenue, Franklin Avenue and Glenholme Avenue. | Agree with Suggested Action/Proposed concept, EA consultant <b>(UEM)</b> will reduce all curb radii to minimum allowable as determined by RMN Transportation Planning, Target 6m radii. | Resolved |

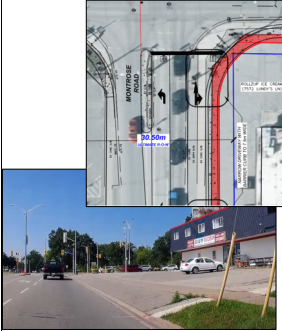
| Issue # | Sheet # | Location | Safety Issue | Photo | Suggested Action/Proposed Concept | Project Owner Response | Resolution |
|---|---|---|---|---|---|---|---|
| 11 | 01 | South leg | Access to 7572 Lundy's Lane from Montrose Road is excessively wide (approximately 40 metres). A note provided in the drawings indicates that the driveway access will be narrowed to 7.5 metres, however it appears that the exact location is still to be determined. Corner clearance standards for arterial roads (upstream of intersection) are in advance of the left turn storage (as a minimum) according to TAC Geometric Design Guide for Canadian Roads (Figure 8.8.2). Placement of the access downstream of the beginning of the left turn storage introduces conflicts between through vehicles and vehicles exiting the driveway access attempting to access the left turn lane. | | Place driveway access as far away from the intersection as practicable. | Agree with Suggested Action/Proposed concept, detailed design consultant will move driveway access as far from the intersection as practicable | Resolved |

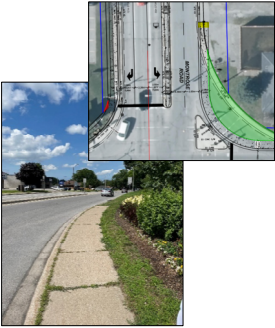
| Issue # | Sheet # | Location | Safety Issue | Photo | Suggested Action/Proposed Concept | Project Owner Response | Resolution |
|---|---|---|---|---|---|---|---|
| 12 | 01 | North leg | The sidewalk on the east side of Montrose Road north of Lundy's Lane ends about 10 metres north of the intersection. The design indicates that the sidewalk will not be extended. Transit with bus stops are provided on the east side of Montrose Road north of this location. | | Review the feasibility of providing a sidewalk on the east side of Montrose Road north of Lundy's Lane. | Extend the sidewalk to match the limit of construction - that way future works will not impact the intersection. This approach should be confirmed with Niagara Falls | Resolved |

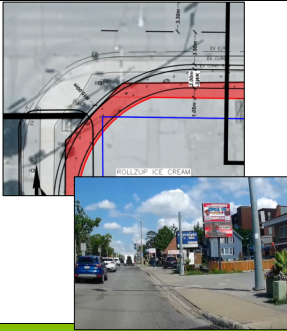
| Issue # | Sheet # | Location | Safety Issue | Photo | Suggested Action/Proposed Concept | Project Owner Response | Resolution |
|---|---|---|---|---|---|---|---|
| 13 | 01 | East leg | Access to 7572 Lundy's Lane from Montrose Road will continue to be provided at its current location. With the increased radius on the southeast corner of the intersection, this access will be immediately downstream of the intersection, exacerbating conflicts between vehicles turning into and out of this access and eastbound through vehicles and northbound right turning vehicles. | | Consider eliminating this access in conjunction with the access improvements detailed above. | The preliminary design will be amended to reduce the current curb radii based on comment in Row 11 and that we'll move the access as far from the intersection as possible. | Resolved |

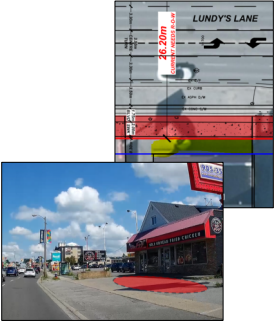
| Issue # | Sheet # | Location | Safety Issue | Photo | Suggested Action/Proposed Concept | Project Owner Response | Resolution |
|---|---|---|---|---|---|---|---|
| 41 | 12 | 6530 Lundy's Lane | The widening of Lundy's Lane and the southward shift of the sidewalk will result in a significant reduction in the size of the parking area in front of this business, increasing the likelihood of conflicts between vehicles backing out across the sidewalk and into the travel lanes on Lundy's Lane. The drawings do not indicate the removal of these parking areas. | | Remove parking areas in front of 6530 Lundy's Lane. | Agree with Suggested Action/Proposed concept, <b>UEM</b> to follow up | Resolved |
