Baker Road Wastewater Treatment Plant Annual Performance Report Treatment and Collection Reporting Year: 2024

Niagara Region – Baker Road Wastewater System 2024 Annual Performance and Summary Report - Treatment

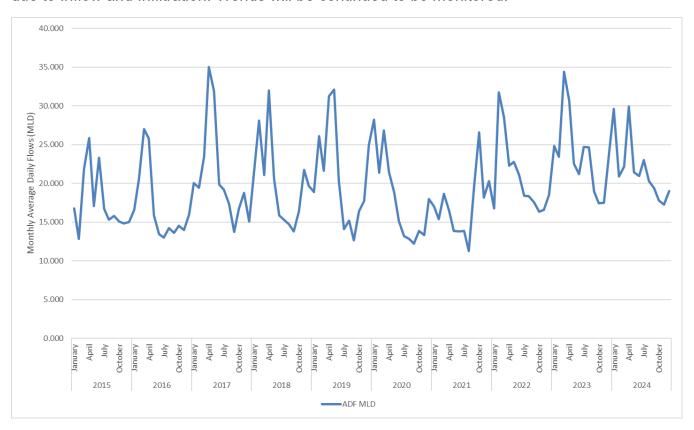
A review of the monthly average daily flow rate for the prior 10-year period was completed. This can be observed below in Figure BR-T-1 below. An increasing trend is noted starting in 2021. Spikes during typical wet weather seasons further support increased flows are occurring due to Inflow and Infiltration. Trends will be continued to be monitored.

Figure BR-T-1: Graph displaying the Monthly Average Daily Flow Rate in MLD

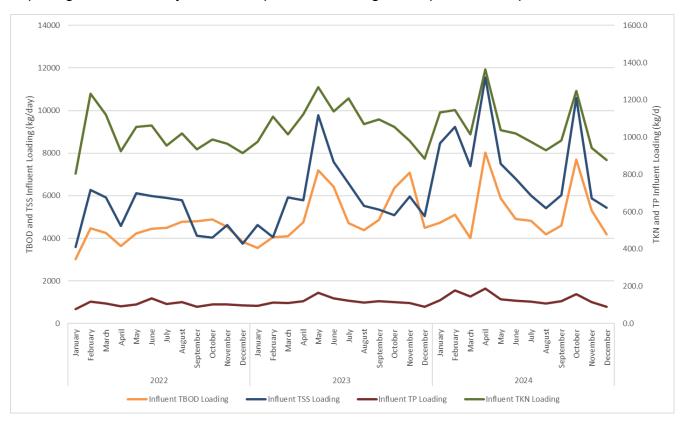
Plant loading is calculated by measuring the average strength of a pollutant per liter of influent sewage and multiplying it by the average volume of sewage received. This is generally displayed as kilograms of pollutant per day or kg/d. Below in Figure BR-T-2, is a graph depicting four commonly monitored pollutant loading to the plant for the period of 2022-2024.

Figure BR-T-2: Figure of monthly plant loadings to the Baker Road WWTP for Total Biochemical Oxygen Demand (TBOD), Total Suspended Solids (TSS), Total Kjeldahl Nitrogen (TKN) and Total Phosphorus (TP), in kg/d, for the period 2022 to 2024.

Reviewing the calculated loadings for TBOD, TSS, TKN and TP for the past three years shows no observable trends in sewage strength received at the plant. Loading will continue to be monitored to ensure proper plant operation.

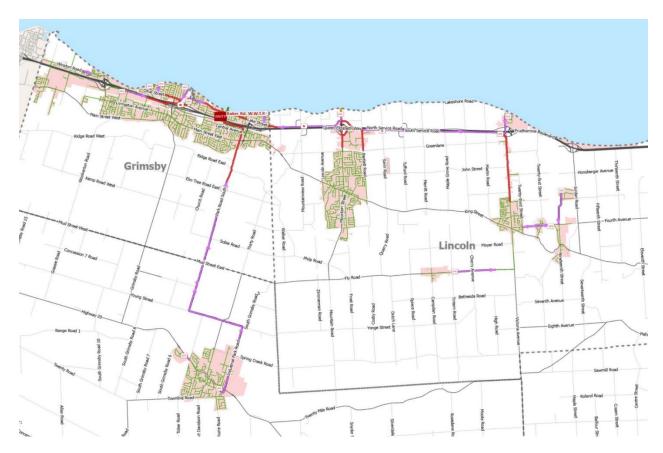
Figure BR-C-1: Map of Baker Road WWTP Collection System

The collection system is operated under a two-tier system, where the Town of Grimsby, Town of Lincoln and Township of West Lincoln own and operate local gravity sanitary sewers and Niagara Region owns and operates sewage pumping stations, forcemains and larger gravity sanitary sewers or trunk sewers. It is classified as a nominally separated system meaning that storm water is collected separately from sanitary sewage but the system may still be impacted by inflow and infiltration from sources such as roof leaders, foundation drains, leaky pipes and joints and maintenance holes.
