## **SIGHTLINE ANALYSIS (UEM)**

## **Lundy's Lane Class Environmental Assessment (Highland Avenue to Montrose Road) Driveway Sight Line Evaluation**

As part of the Lundy's Lane Schedule C Class Environmental Assessment (Class EA), a sight line evaluation of all driveway exits within the study area (Highland Avenue to Montrose Road) was undertaken. The evaluation aimed to identify properties with sight line issues affecting vehicles turning left or right from driveways onto Lundy's Lane.

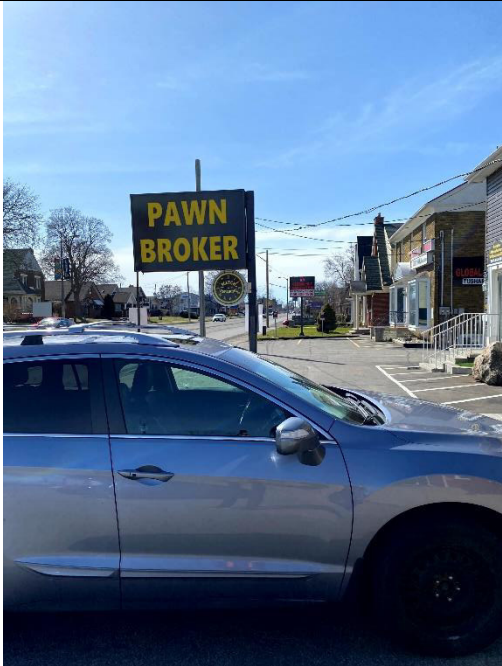
| LUNDY'S LANE NORTH SIDE | | | | | |
|---|---|---|---|---|---|
| 6925 LUNDY'S LANE | 14.93 | Retail (Kick Ash Vape) | ✓ | <input type="checkbox"/> | <div></div> <div><ul style="list-style-type: none"><li>Approximate available site distance from the left – 65m</li><li>Existing bus stop/signs present a minor site line obstruction</li><li>Parked vehicles will cause a site line obstruction for vehicles exiting onto Lundy's Lane</li></ul><ul style="list-style-type: none"><li>Approximate available site distance from the right – 240m</li><li>No site line obstructions present</li><li>Parked vehicles will cause a site line obstruction for vehicles exiting onto Lundy's Lane</li></ul></div> |

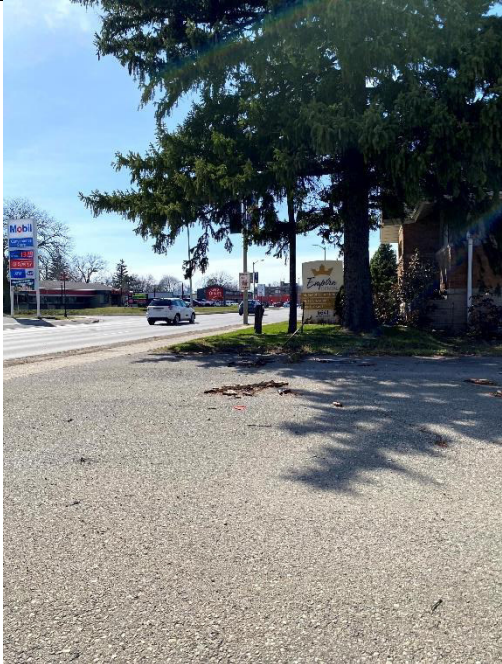
| LUNDY'S LANE NORTH SIDE | | | | | |
|---|---|---|---|---|---|
| 6629 LUNDY'S LANE | 14.48 | Vacant | ✓ | ✓ | <div><div></div><div><ul style="list-style-type: none"><li>• Approximate available site distance from the left – 60m</li><li>• Existing 'Home Lighting' building presents a major site line obstruction</li><li>• Recommendation is to remove the existing building</li></ul></div></div> <div><div></div><div><ul style="list-style-type: none"><li>• Approximate available site distance from the right – 140m</li><li>• Existing "Empire Dental" sign presents a minor site line issue</li><li>• Recommendation is to relocate the existing sign</li></ul></div></div> |

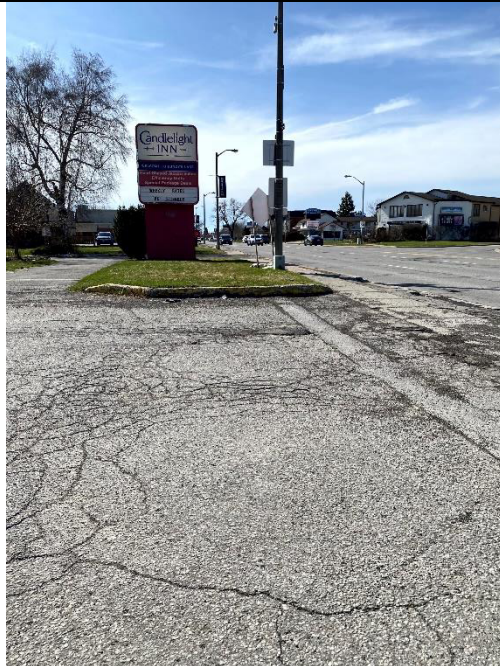
| LUNDY'S LANE SOUTH SIDE | | | | | |
|---|---|---|---|---|---|
| 7600 LUNDY'S LANE | 88.39 | Commercial (Restaurant – Mick & Angelos) | ✓ | <input type="checkbox"/> | <div><div><ul style="list-style-type: none"><li>• Approximate available site distance from the left – 180m</li><li>• No site line obstructions present</li></ul></div><div><ul style="list-style-type: none"><li>• Approximate available site distance from the right – 280m</li><li>• Parked vehicles present minor site line issue when present</li></ul></div></div> |

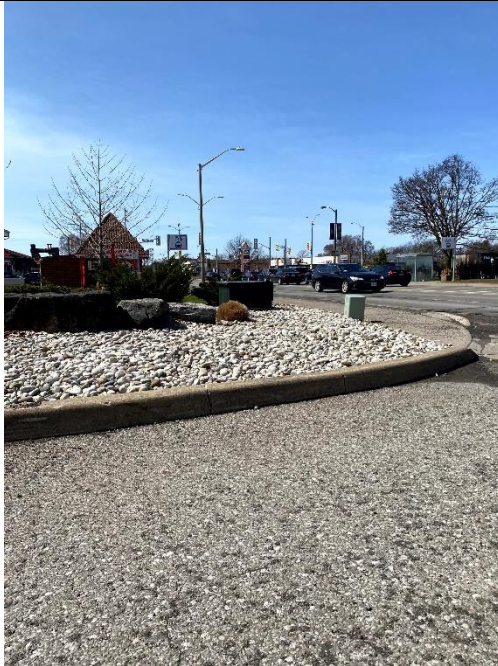
| <b>B. MONTROSE RD TO QEW OVERPASS</b> | | | | | |
|---|---|---|---|---|---|
| 7514 LUNDY'S LANE | 49.52 | Commercial (Comfort Inn & IHOP Restaurant) | ✓ | ✓ | <div style="display: flex; justify-content: space-around;"> </div> <div style="display: flex; justify-content: space-around;"> <ul style="list-style-type: none"> <li>• Approximate available site distance from the left – 110m</li> <li>• Existing shrubs present a minor siteline issue</li> <li>• Existing building presents a major site line issue</li> <li>• Recommendation is to remove/relocate the existing building and shrubs</li> </ul> <ul style="list-style-type: none"> <li>• Approximate available site distance from the right – 250m</li> <li>• No site line obstructions present</li> </ul> </div> |

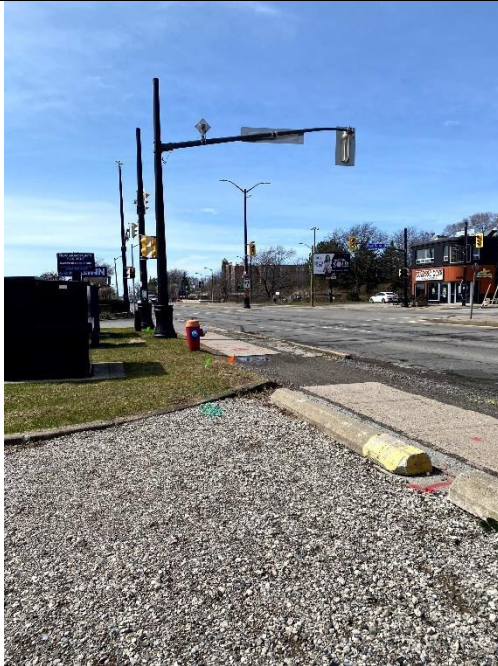
| C. Q.E.W. OVERPASS TO HYDRO CANAL | | | | | |
|---|---|---|---|---|---|
| 7256/7230 LUNDY'S LANE | 33.51 | Vacant | <input type="checkbox"/> | <input type="checkbox"/> | <div style="display: flex; justify-content: space-around;"> <div style="text-align: center;"> <ul style="list-style-type: none"> <li>• Approximate available site distance from the left – 240m</li> <li>• No site line obstructions present</li> </ul> </div> <div style="text-align: center;"> <ul style="list-style-type: none"> <li>• Approximate available site distance from the right – 180m</li> <li>• No site line obstructions present</li> </ul> </div> </div> |

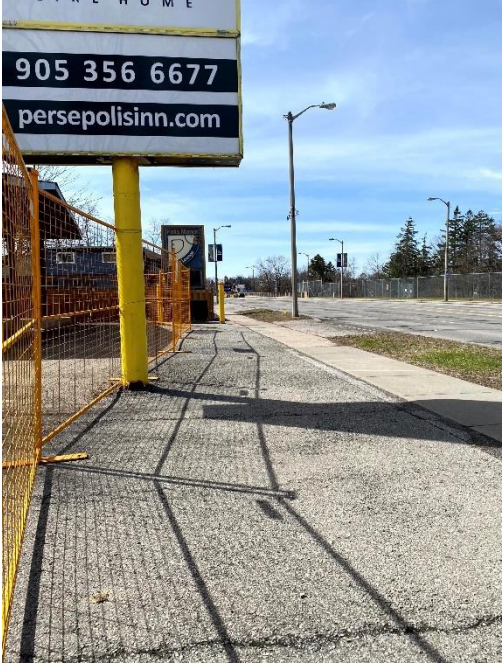
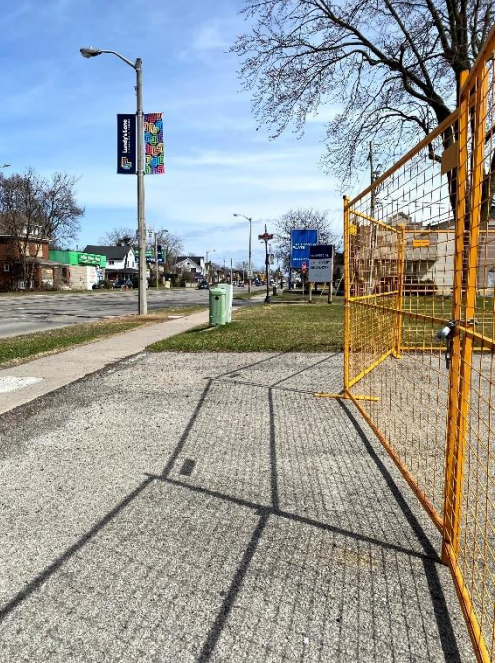
| 7070<br>LUNDY'S<br>LANE | 29.45 | Commercial (The Americas Hospitality Inn & Rest. - closed.) | ✓ | <input type="checkbox"/> | <ul style="list-style-type: none"> <li>• Approximate available site distance from the left – 110m</li> <li>• Could not measure from the proper distance from back of proposed curb due to the site fencing</li> <li>• Once the sign at 7114 Lundy's Lane is removed/relocated, no site line obstructions will be present</li> </ul> | <ul style="list-style-type: none"> <li>• Approximate available site distance from the right – 240m</li> <li>• No site line obstructions present</li> </ul> |

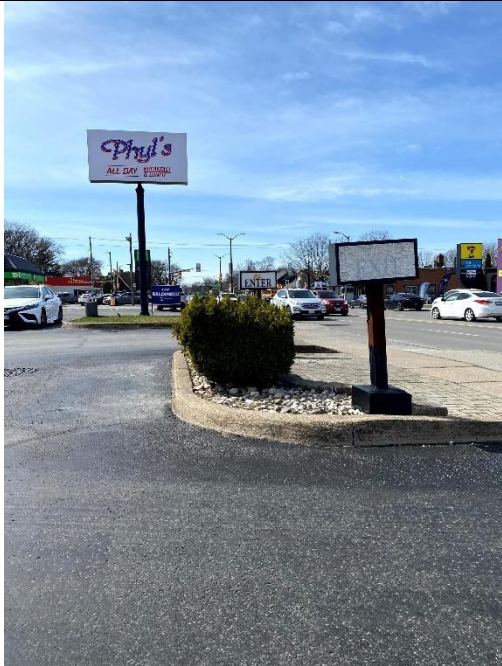
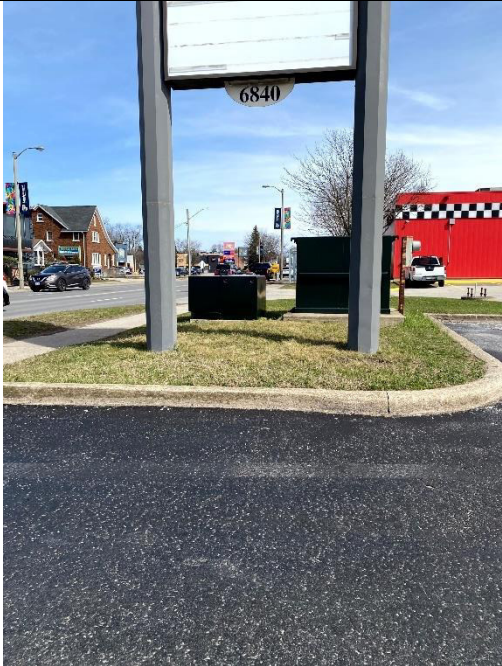
| LUNDY'S LANE SOUTH SIDE | | | | | |
|---|---|---|---|---|---|
| 6840 LUNDY'S LANE | 33.68 | Commercial Restaurant (Carpaccio's) | ✓ | <input type="checkbox"/> | <div><div><ul style="list-style-type: none"><li>• Approximate available site distance from the left – 230m</li><li>• Recommendation is to remove/relocate the existing shrub</li></ul></div><div><ul style="list-style-type: none"><li>• Approximate available site distance from the right – 80m</li><li>• There is partial visibility over the shorter transformer</li><li>• Transformer may require relocation</li></ul></div></div> |

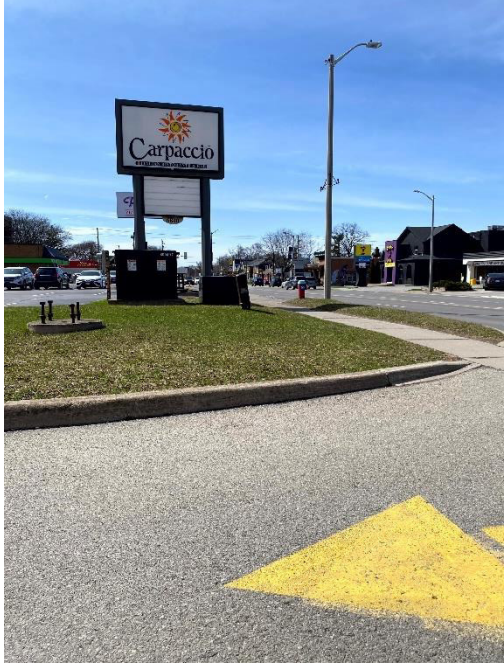
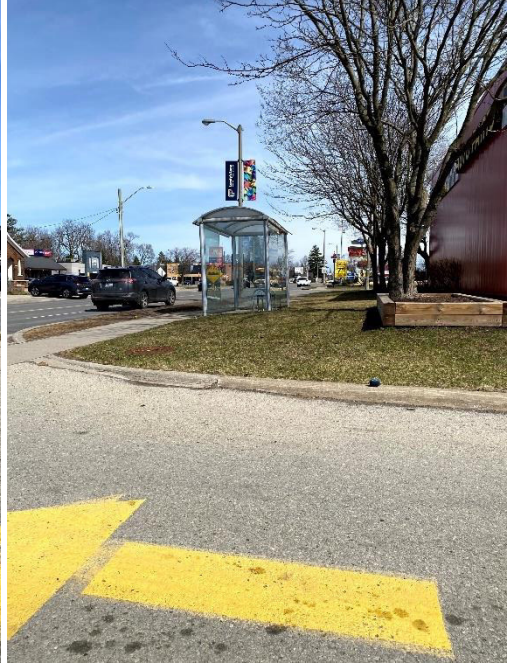
| 6812<br>LUNDY'S<br>LANE | 39.48 | Commercial (Parts<br>Source) | ✓ | <input type="checkbox"/> | <div data-bbox="951 240 1451 899"> </div> <div data-bbox="1451 240 1955 899"> </div> <div data-bbox="951 899 2001 1031"> <ul style="list-style-type: none"> <li>• Approximate available site distance from the left – 140m</li> <li>• Partial site line obstruction with transformer</li> <li>• Approximate available site distance from the right – 200m</li> <li>• No site line obstruction present</li> </ul> </div> |

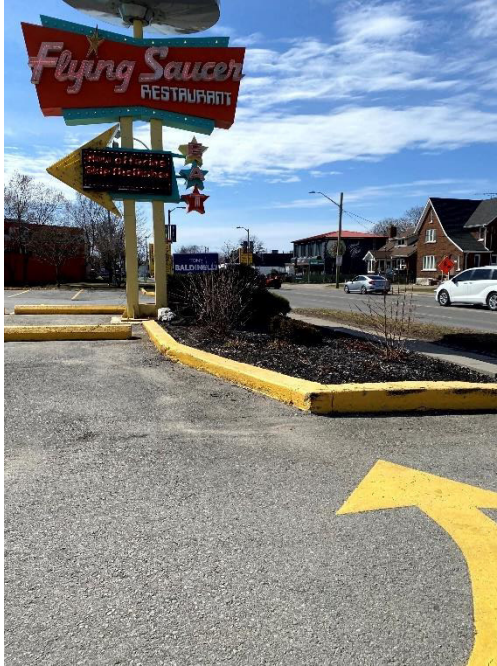
| <b>G. CORWIN AVE TO CARLTON AVE</b> | | | | | |
|---|---|---|---|---|---|
| 6768<br>LUNDY'S<br>LANE | 35.66 | Commercial<br>Restaurant (Flying<br>Saucer) | ✓ | <input type="checkbox"/> | <div> <ul style="list-style-type: none"> <li>• Approximate available site distance from the left – 140m</li> <li>• Existing shrubs/signs present a minor site line obstruction</li> <li>• Recommendation is to remove/relocate the existing shrubs/signs</li> </ul> </div> <div> <ul style="list-style-type: none"> <li>• Approximate available site distance from the right – 190m</li> <li>• No site line obstruction present</li> </ul> </div> |
