### **NATURAL HERITAGE REPORT**

**NATURAL HERITAGE SUMMARY REPORT**  
**FOR THE ROAD AND DRAINAGE IMPROVEMENTS ON REGIONAL ROAD 81**  
**(KING STREET) BETWEEN GREENLANE AND LINCOLN AVENUE, IN THE**  
**TOWN OF LINCOLN**

The Regional Municipality of Niagara

Colville Consulting Inc.

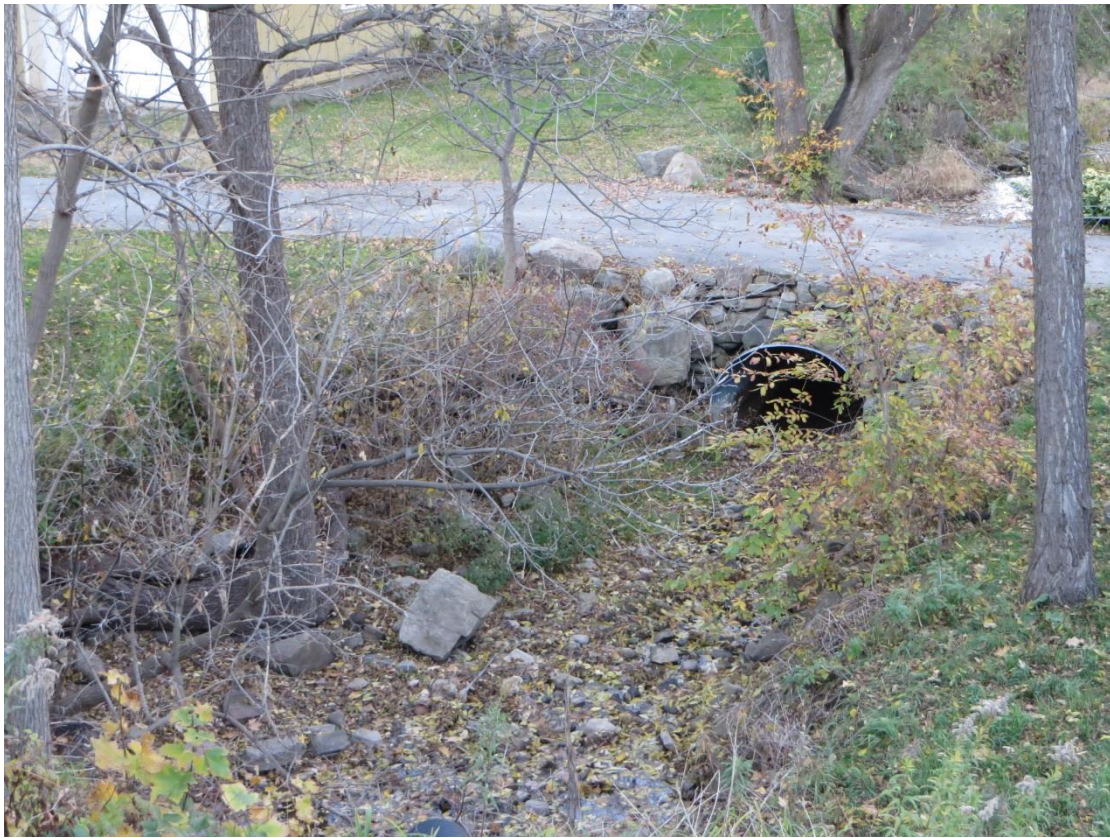
Photo 1: Example of conditions surrounding the main channel of Thirty Mile Creek facing downstream.

The main channel of 30 Mile Creek within the Study Area is located west of 30 Road at municipal address 5536 King Street. This channel flows in northeastern direction originating south of the Grimsby Woodlot Wetland Complex and ultimately exiting into Lake Ontario. During our assessment, upstream and downstream conditions of the watercourse within the Study Area were assessed. Upstream, the watercourse bisects 5515 King Street and 5536 King Street downstream. At the time of our assessment, the water level was low and the rocky substrate could be seen downstream. The watercourse was surrounded by thick vegetation and woodland. Trees within the area are associated with a deciduous woodland primarily consisting of maple species.

No fish species or species at risk were observed during our assessment. Based on our assessment, conditions surrounding watercourse 1 do not provide suitable habitat for fish species. It is our understanding that fish may be using this watercourse in other areas but not within the Study Area due to current conditions. Any alteration or adjustment to this watercourse as a result of the road reconstruction is not likely to impact potential fish habitat further downstream or upstream.

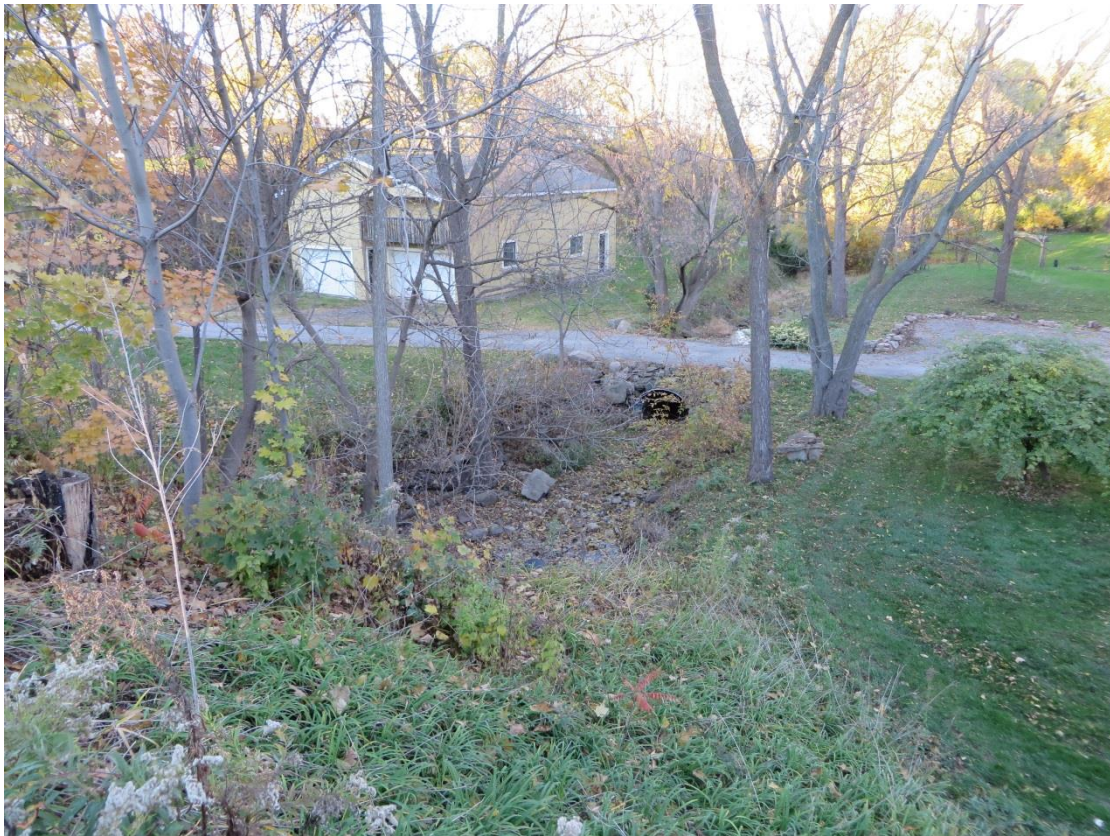
Photo 2: Example of conditions surrounding the main channel of Thirty Mile Creek facing downstream.

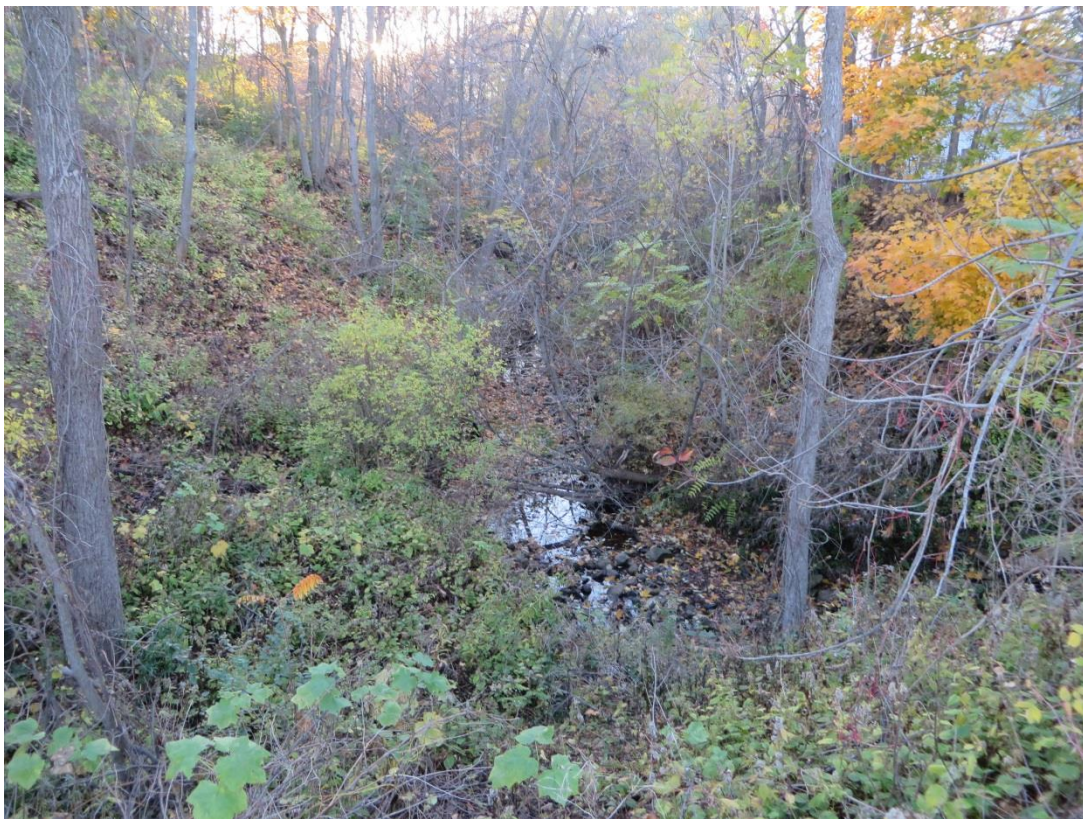
Photo 3: Example of conditions surrounding the main channel of Thirty Mile Creek facing upstream.

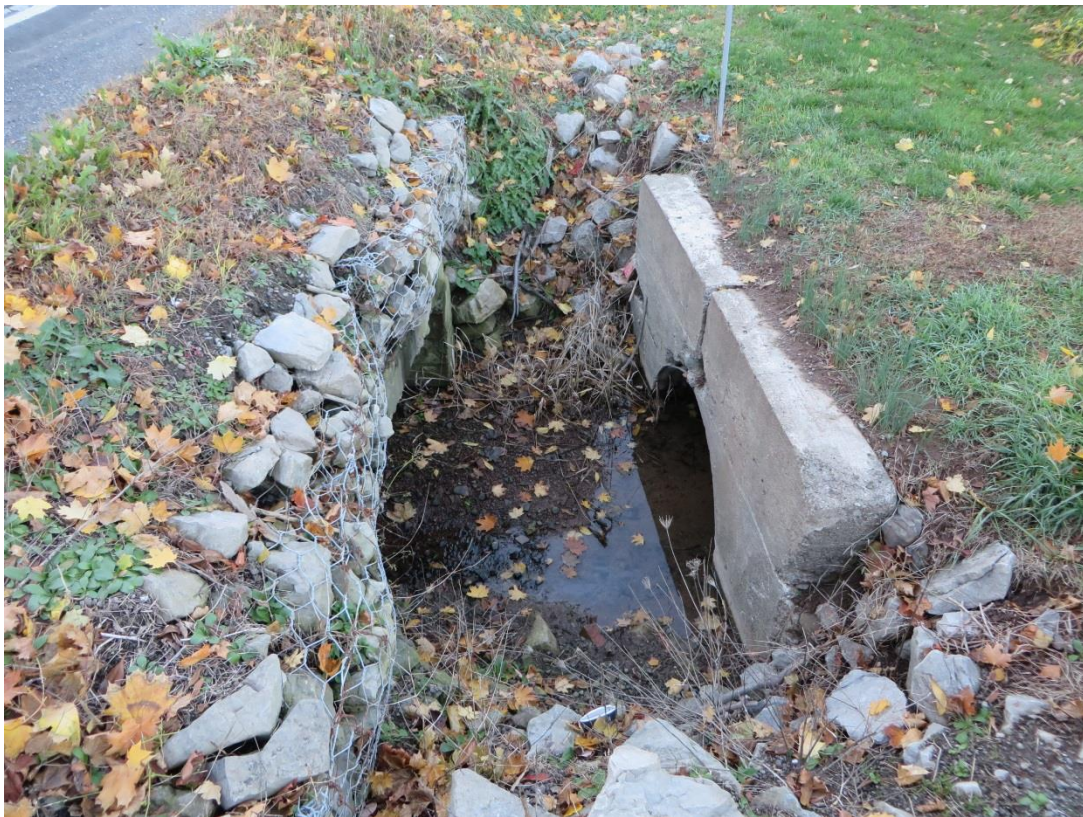
Photo 4: Example of conditions surrounding the main channel of Lake Ontario tributary 24 facing downstream.

Watercourse 3 is a tributary associated with a main channel of Lake Ontario and crosses the Study Area at 5407 King Street. The tributary flows from the south through the Beamsville Escarpment West Wetland Complex north towards Lake Ontario. Our assessment of this watercourse was conducted west of the establishment located at 5407 King Street and on the south side of Regional Road 81 (King Street) east of 5418 King Street.

A cement culvert surrounded by confined rip rap can be seen on the north side of the road. Water was observed in a space between the road and culvert (approximately 1 metre in length) of. The watercourse continues underground through roughly 5m of manicured lawn and exits through a smaller secondary culvert where it continues flowing uncovered northward. At the time of our assessment water flow in Watercourse 3 was not observed and the channel was highly vegetated.

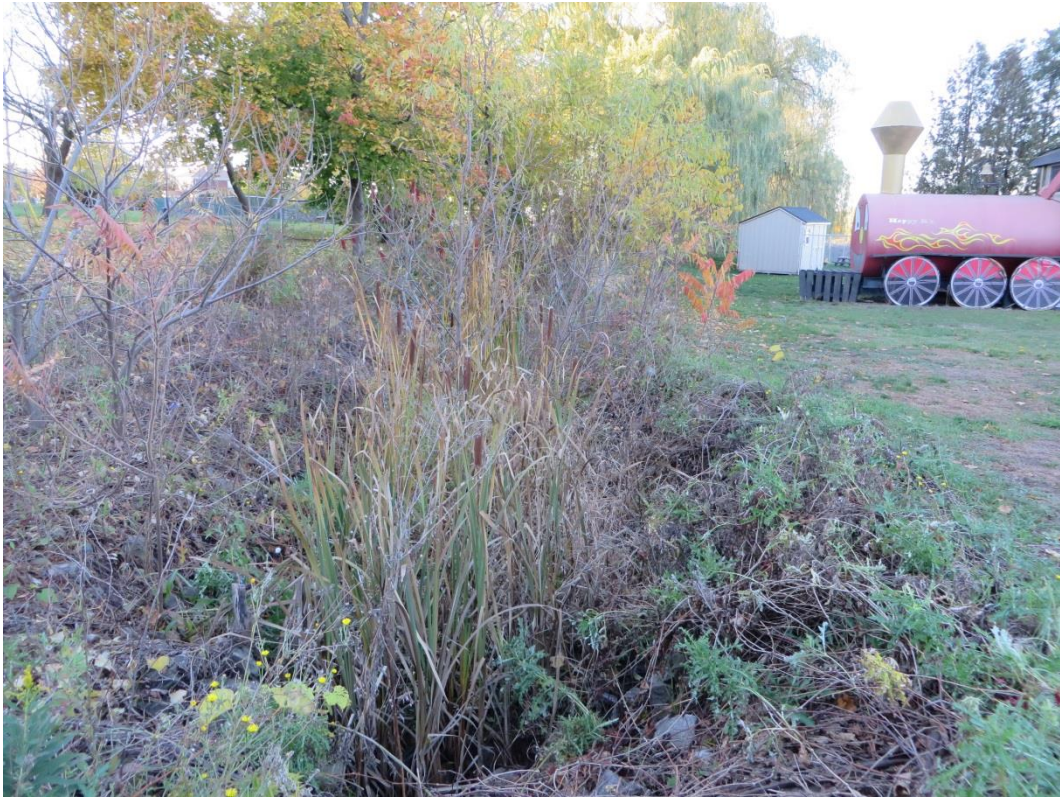
Photo 5: Example of conditions surrounding the main channel of Lake Ontario tributary 24 facing downstream.

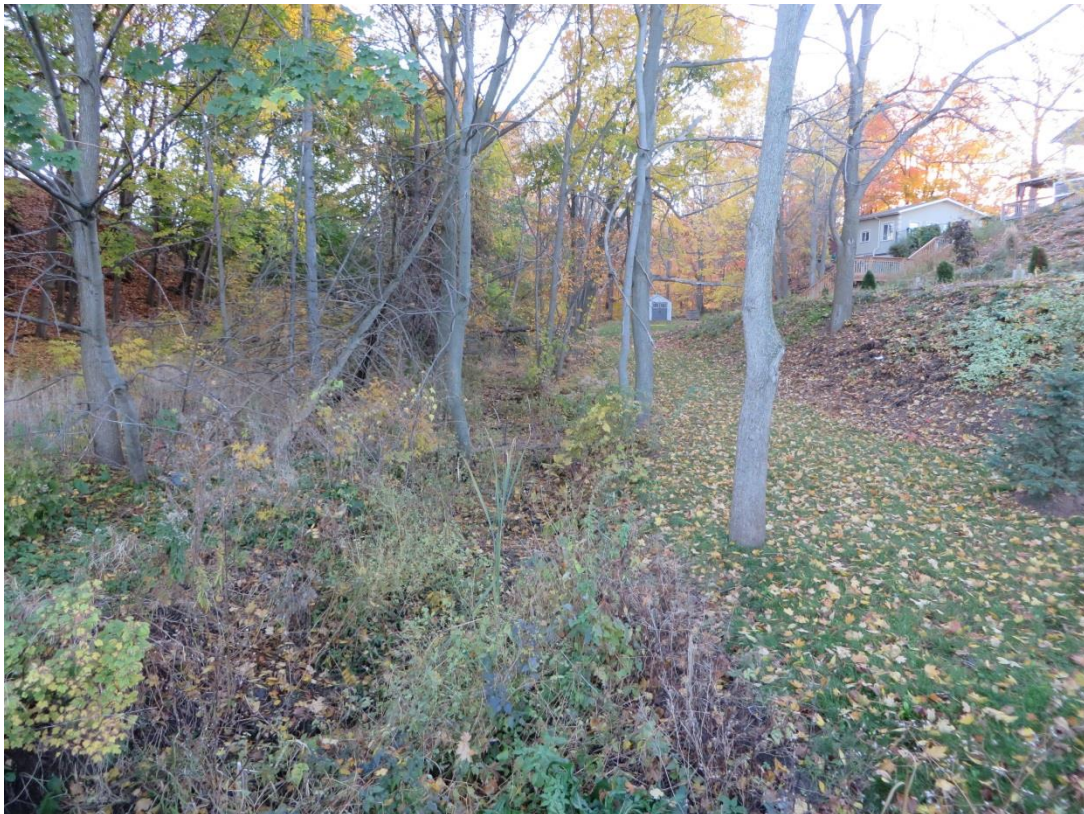
Photo 6: Example of conditions surrounding the main channel of Lake Ontario tributary 24 facing upstream.

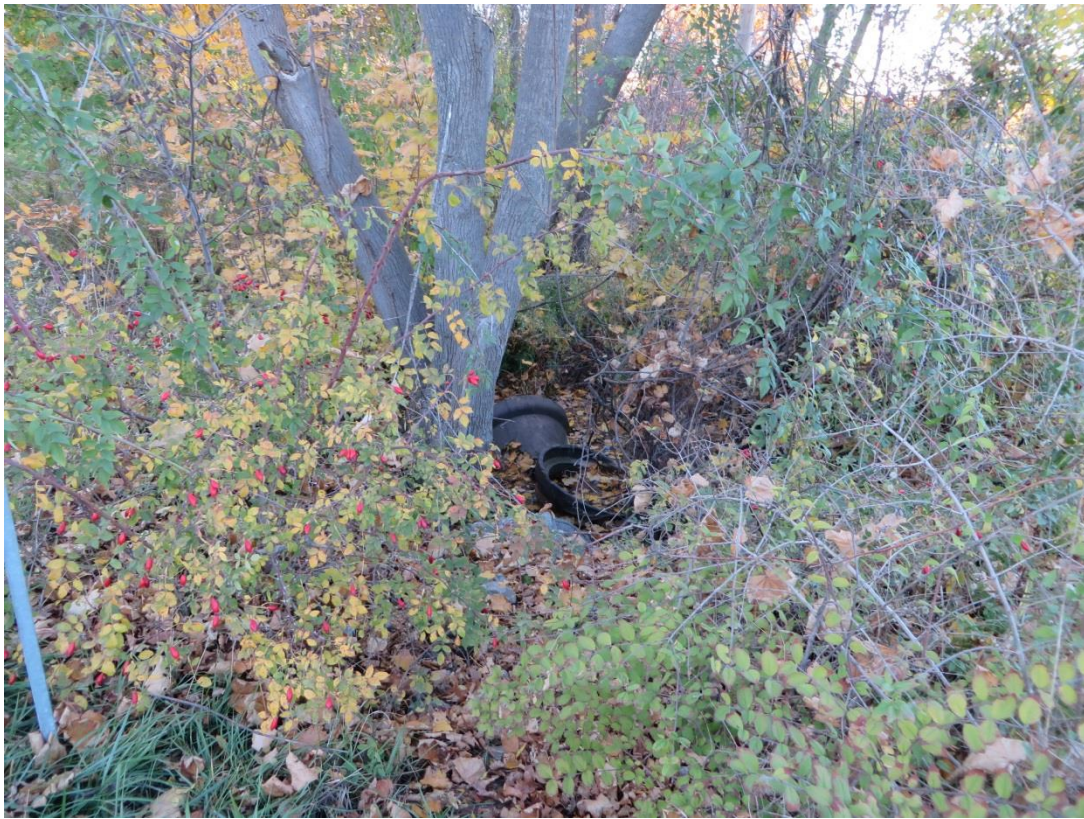
Photo 7: Example of conditions surrounding the tributary to Thirty Mile Creek facing downstream.

Watercourse 2 functions as a tributary to 30 Mile Creek and bisects the Study Area east of 30 Road and crosses Regional Road 81 (King Street) at 5480 King Street. The tributary convenes with the main channel of 30 Mile Creek approximately 124 metres north of Regional Road 81 (King Street) and continues southwest towards Grimsby Woodlot Wetland Complex and further south into additional tributaries.

The location of our assessment for this watercourse feature was downstream at 5480 King Street and upstream at 5477 King Street. Conditions surrounding the watercourse were similar to that of watercourse 1, however several Weeping Willows were adjacent to the watercourse. An abundance of leaf litter, fallen branches and man-made debris was observed close to the downstream culvert. Similar to Watercourse 1, Watercourse 2 does not provide sensitive habitat.

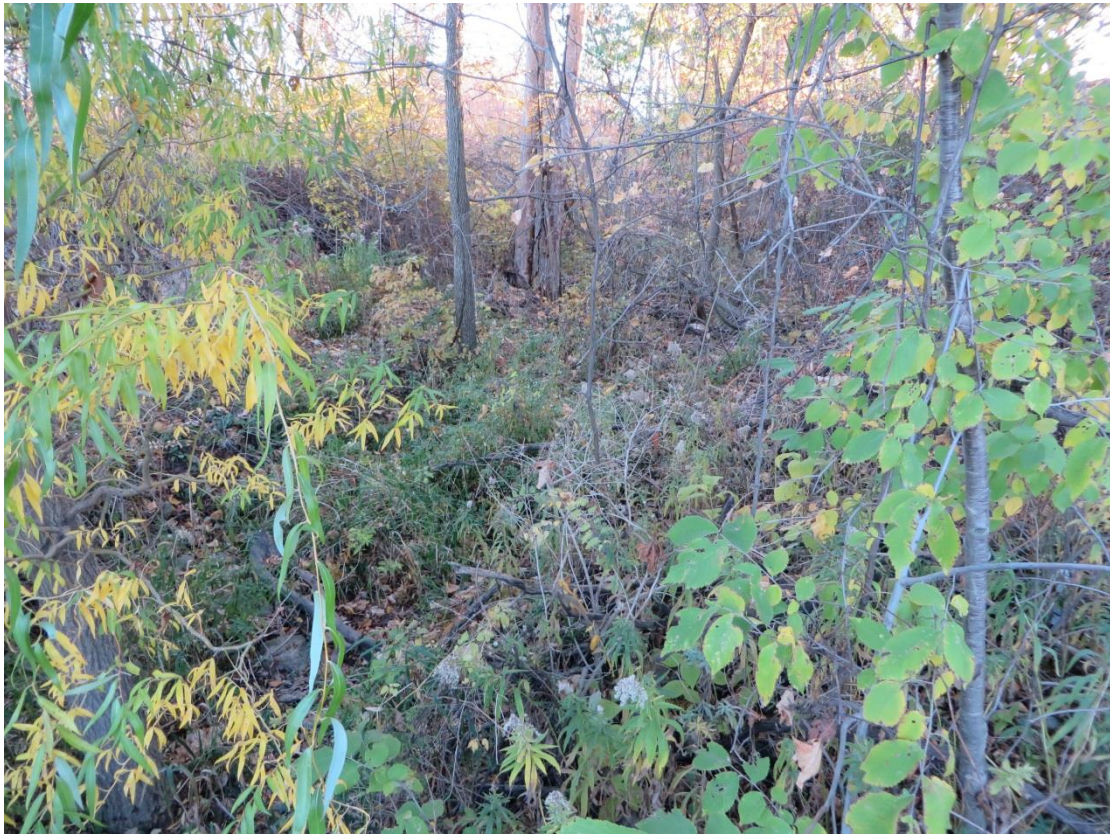
Photo 8: Example of conditions surrounding the tributary to Thirty Mile Creek facing upstream.

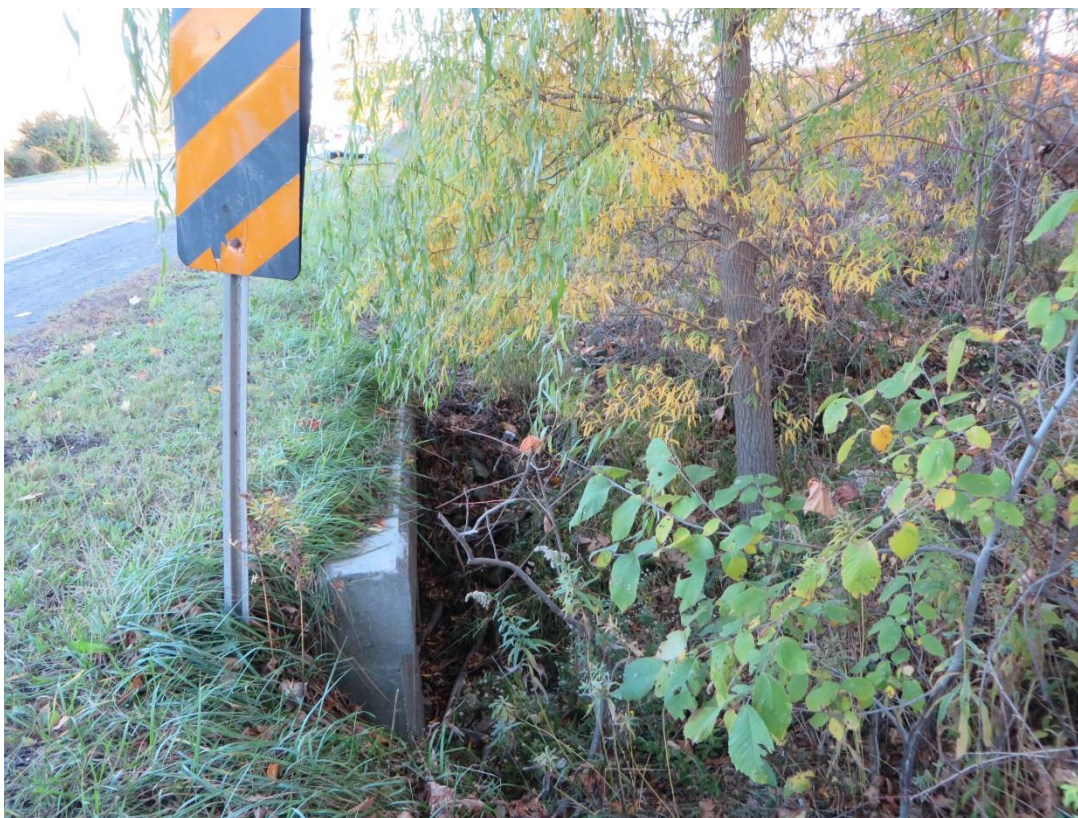
Photo 9: Example of conditions surrounding the tributary to Thirty Mile Creek facing upstream.

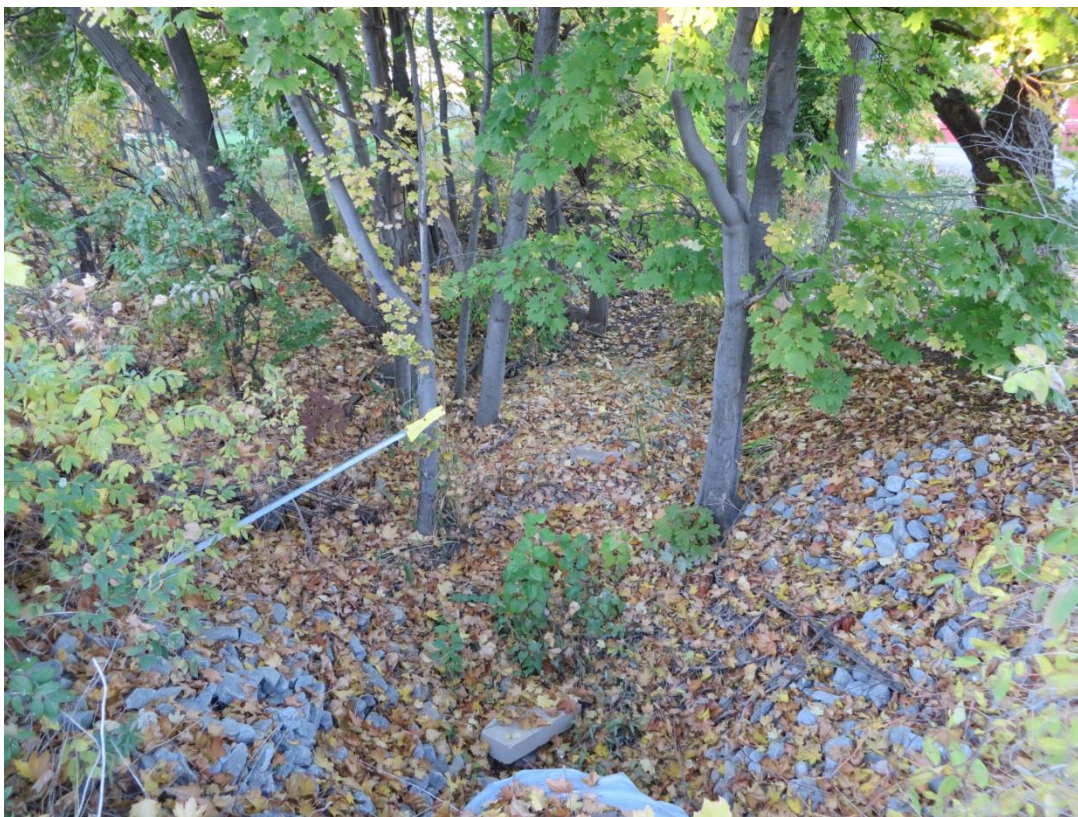
Photo 10: Example of conditions surrounding tributary to Konkle Creek facing downstream of 5310 King Street

The most eastern crossing assessment location was directly west of the driveway of 5310 Regional Road 81 (King Street). Water flows northward through a small round steel culvert and exits into a narrow rocky channel surrounded by trees. The water level of this portion of the tributary was very low and difficult to see through the abundance of leaves and other vegetation

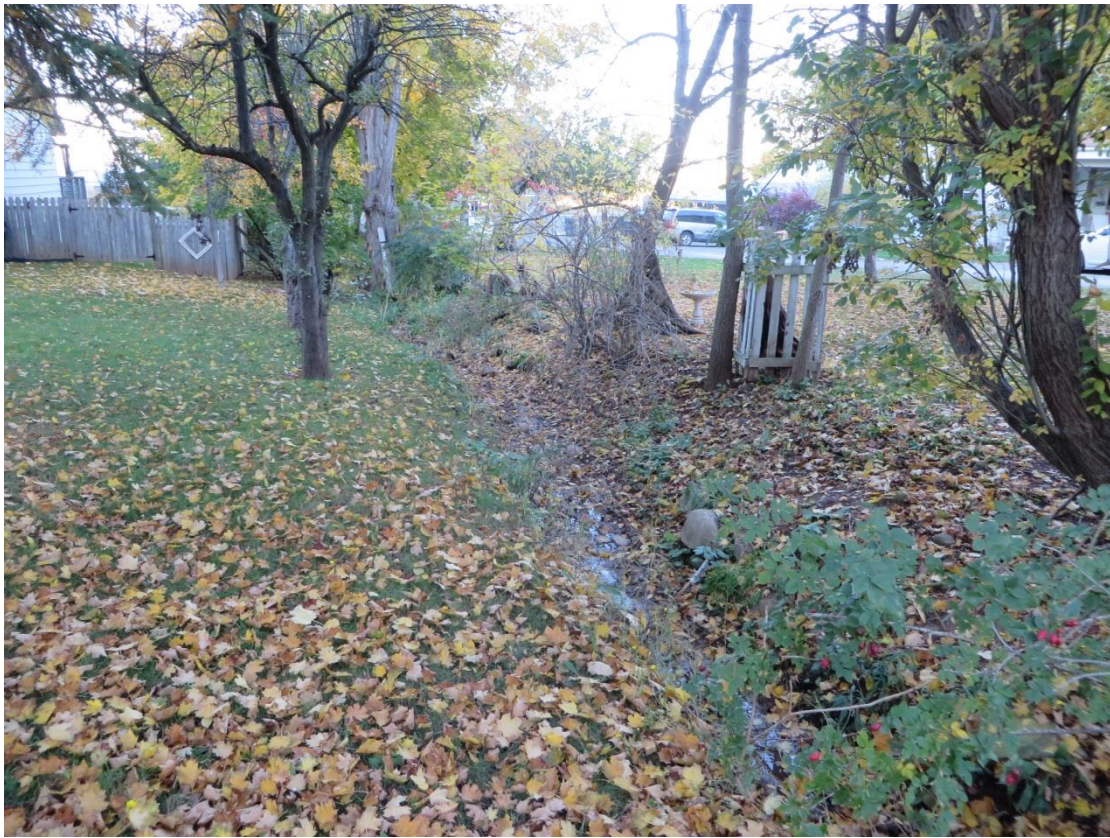
Photo 11: Example of conditions surrounding tributary to Konkle Creek west of 5359 King Street.

Our assessment was conducted at the addresses mentioned above. The watercourse at 5359 King Street was located roughly 40 metres east of the driveway on the north side of Regional Road 81 (King Street). The watercourse in this area exits a small culvert and is approximately 2 metres at its widest. During our assessment, no water was observed and rocky substrate and thick vegetation lining the banks was noted.

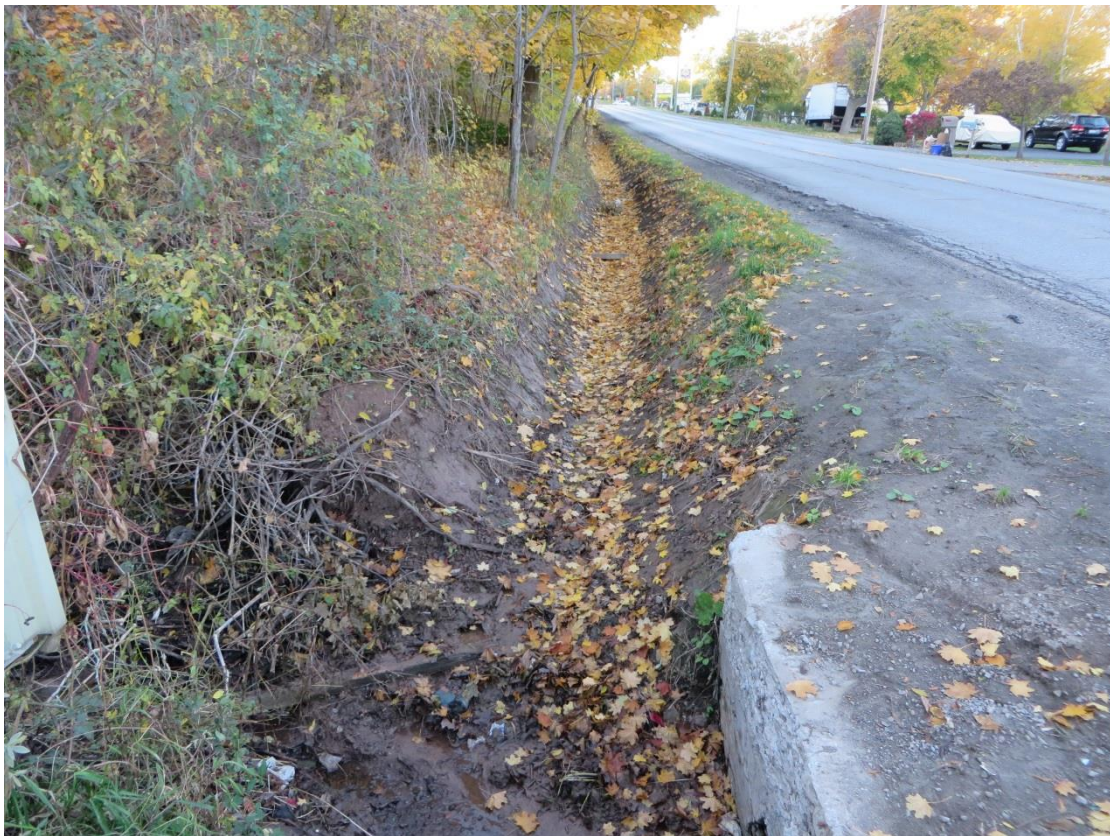
Photo 12: Example of conditions surrounding tributary to Konkle Creek east of 5366 King Street.

A drainage ditch originating on the south side of Regional Road 81 (King Street) across from 5359 King Street enters watercourse 2 at 5366 King Street. This drainage ditch parallels the road and receives runoff from Regional Road 81 (King Street). This portion of the watercourse had very little water flow and appeared that the watercourse was being choked out by the overgrown vegetation.

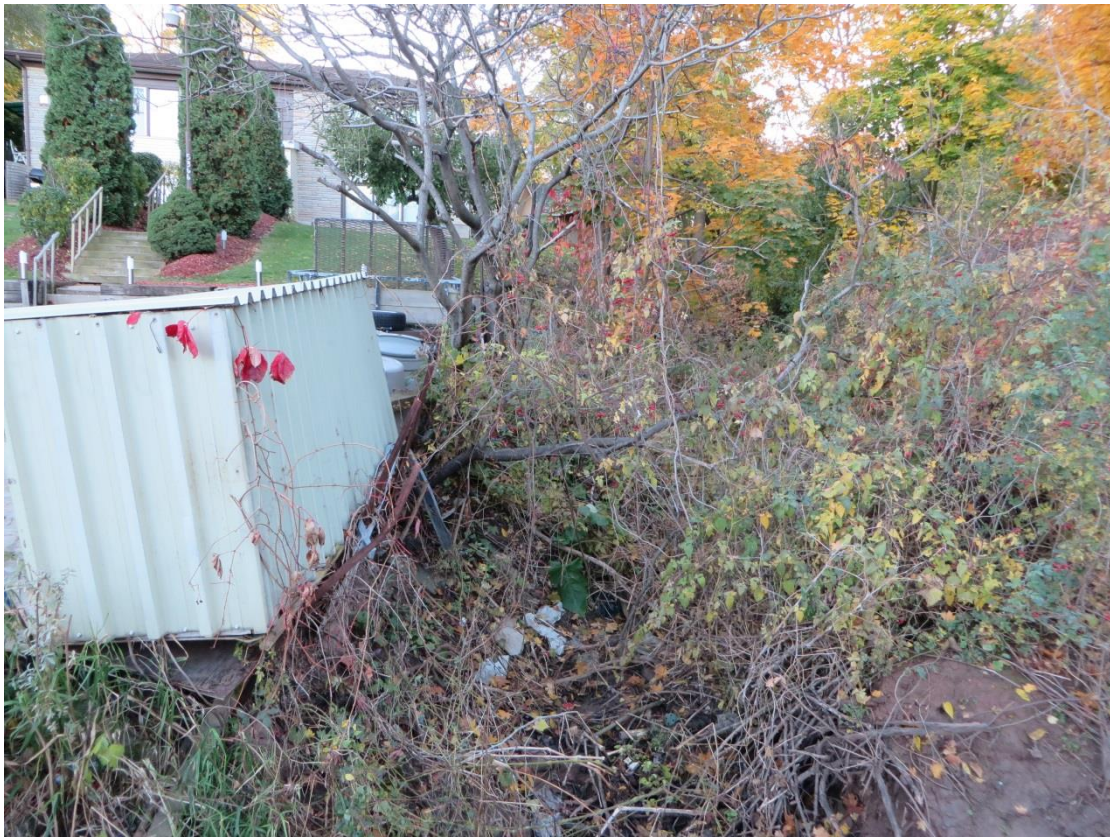
Photo 13: Example of conditions surrounding tributary to Konkle Creek west of 5366 King Street.
