# PROPOSED UPPER'S QUARRY LEVEL 1 AND 2 WATER STUDY REPORT

**WALKER AGGREGATES INC.**

WSP PROJECT NO.: 161-11633-00  
DATE: OCTOBER 2021

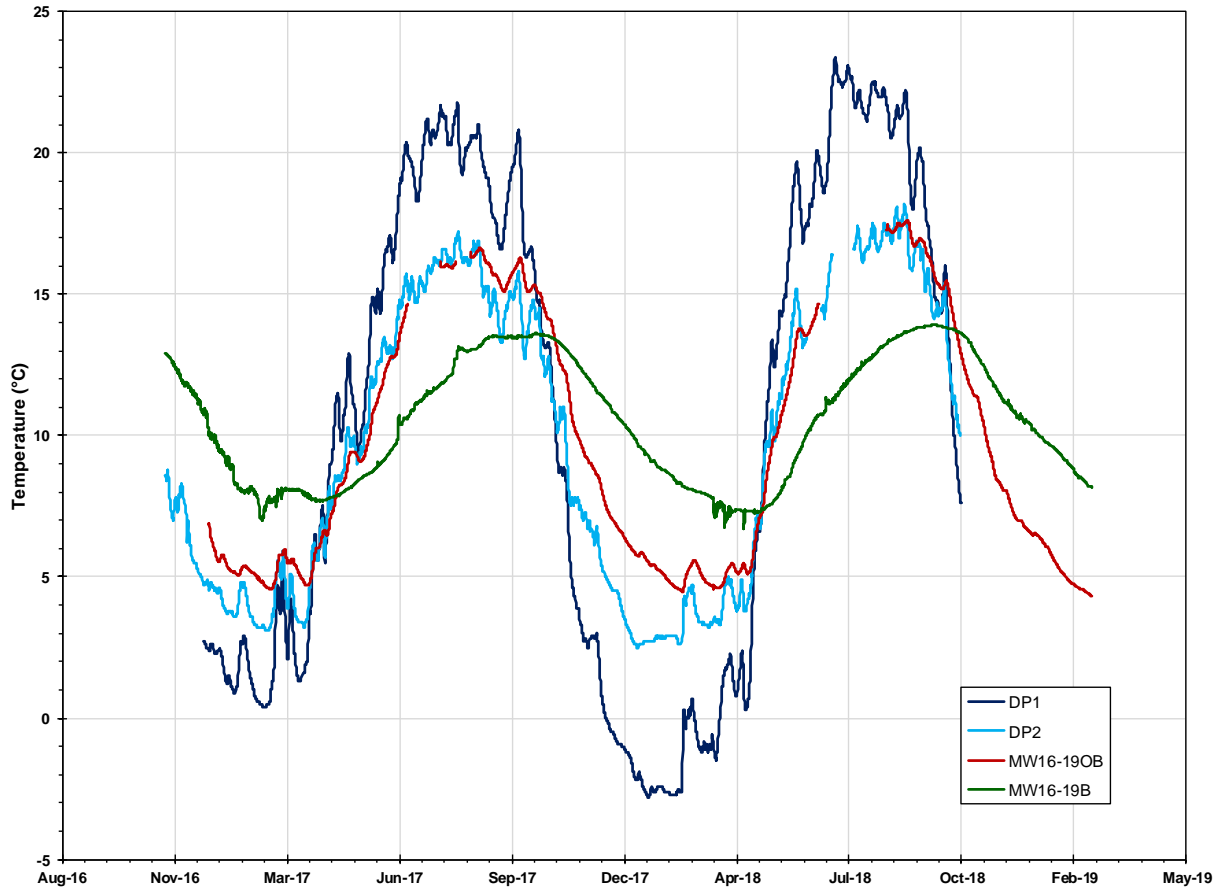
In addition to water quality, temperature effects of the proposed quarry discharge on the Existing Watercourse and Beaverdams Creek have also been considered. The dataloggers that were installed to record water levels in the monitoring wells and surface water drivepoints also record temperature. Water temperature data for Beaverdams Creek (DP1) and the Existing Watercourse at the northern property boundary (DP2) are available since approximately November 2016. These data are included on the plot of water temperature shown below. For the groundwater temperature comparison, the data from nest MW16-19 shown on the plot below were chosen as this well nest has the thinnest overburden deposit encountered in the drilling program (i.e., groundwater at MW16-19 is the most susceptible to warmer surface temperatures during the summer months).

In southern Ontario, groundwater temperatures in the bedrock generally cycle within a relatively narrow range that tends to slightly lag the seasonal air temperature cycle. The plot of shallow bedrock aquifer groundwater temperature data from MW16-19B follows this pattern, ranging between approximately 8°C in early spring to approximately 14°C in early autumn. The plots of temperature data from MW16-19OB and DP2 are more similar, ranging from approximately 3°C in mid-winter to 17°C in mid-summer, since DP2 is located in a groundwater discharge zone. Finally, the plot of temperature data for DP1 follows a similar cycle to that of DP2, but the temperature extremes are more severe, ranging from approximately 0°C in mid-winter to 22°C in mid-summer.

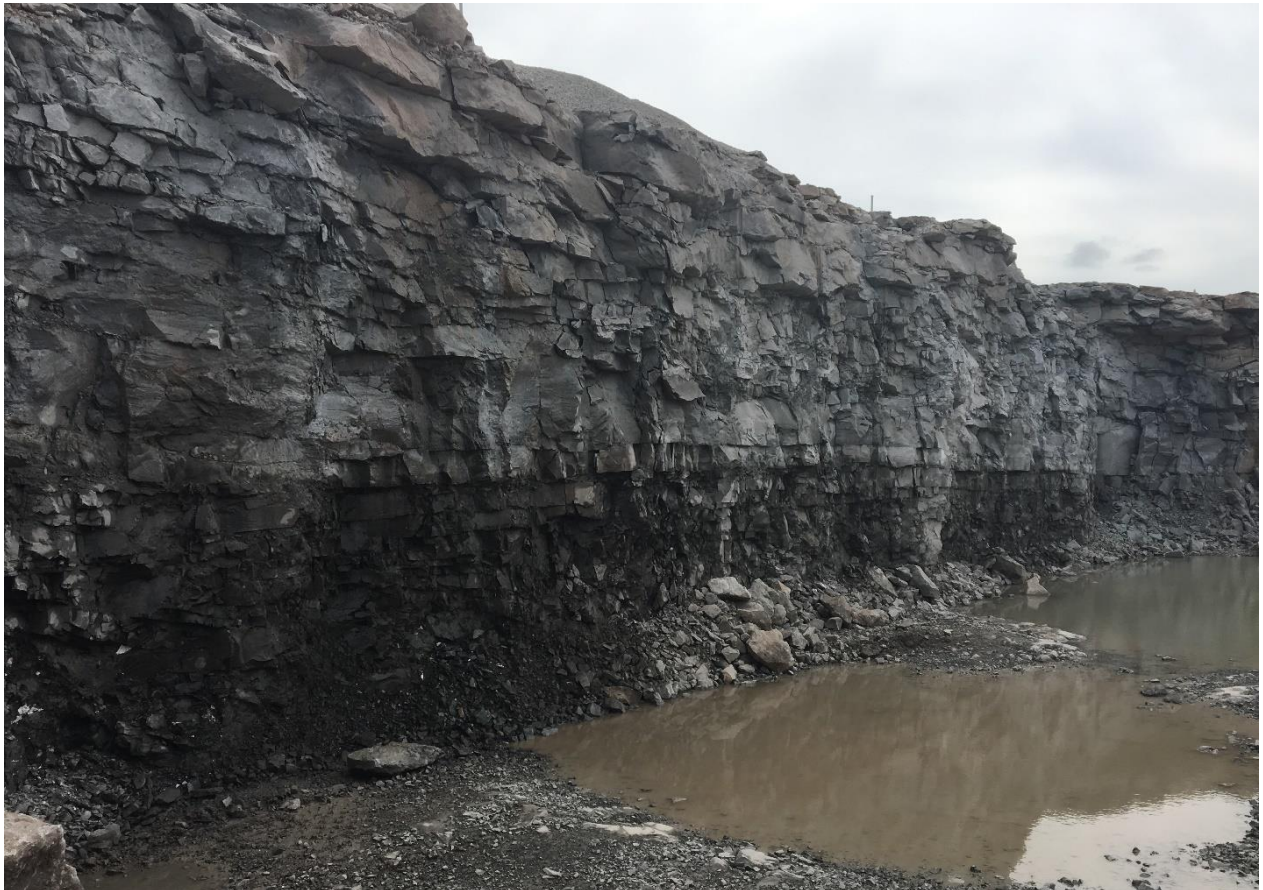
**Photo 1**            **Quarry Face at Existing Walker Brothers Quarry**
